**AIRPROX REPORT No 2023106**

Date: 03 Jun 2023 Time: 1200Z Position: 5209N 00106W Location: 1NM SSE DTY VOR/DME

**PART A: SUMMARY OF INFORMATION REPORTED TO UKAB**

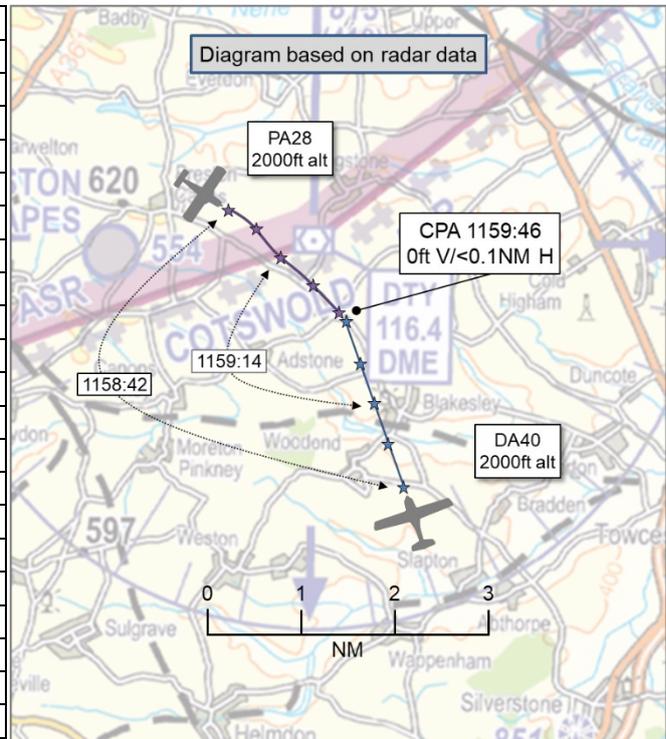
The CPA occurred at 1159:46, approximately 2NM south of the DTY VOR/DME. The situation display showed the returns of the DA40 and an aircraft on a 7000 squawk merge, with both Mode C readouts indicating A023. No communication on this occurrence had been relayed via the RT, and the ATC watch logs likewise do not reference it.
