AIRPROX REPORT No 2023130

Date: 22 Jun 2023 Time: 1505Z Position: 5115N 00208W Location: Westbury White Horse

PART A: SUMMARY OF INFORMATION REPORTED TO UKAB

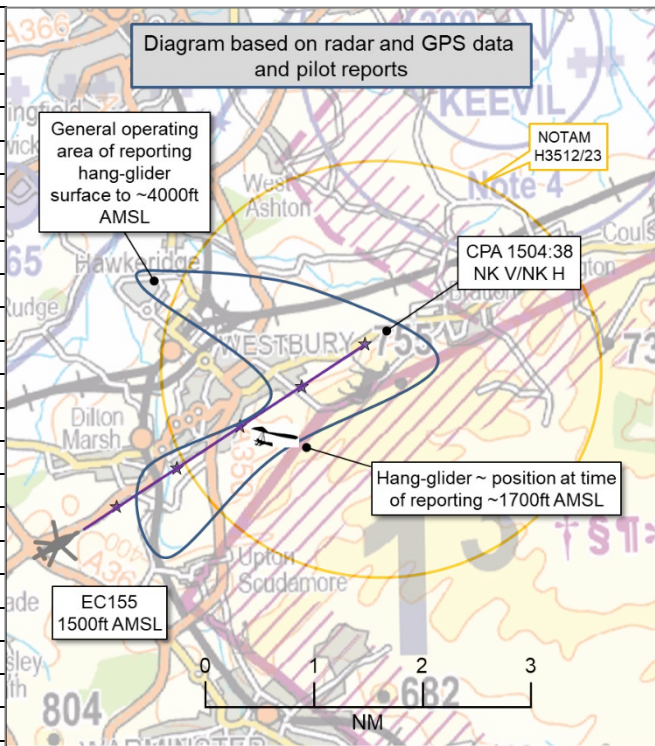
THE HANG-GLIDER PILOT reports that multiple hang-gliders and paragliders had been soaring at Westbury White Horse, with a CANP in place, at altitudes between ground and cloudbase (4700ft). A helicopter directly overflew the White Horse from the Westbury direction and directly between 2 soaring/circling hang-gliders at approximately 1500ft. One hang-glider steepened the circle so as to present the largest visible area, although the sighting had been so late that it probably made little difference. Although the risk of collision was [judged to be] low, the presence of D148 is forcing GA to overfly the hang-gliding launch by creating a pinch point between D148 and D123, thereby increasing risks. Perhaps a permanent NOTAM of intense hang-glider/paraglider activity in that area is required to avoid any further and more serious conflicts.
