**AIRPROX REPORT No 2023168**

Date: 07 Aug 2023 Time: 1241Z Position: 5223N 00018W Location: IVO Buckworth, Cambs

**PART A: SUMMARY OF INFORMATION REPORTED TO UKAB**

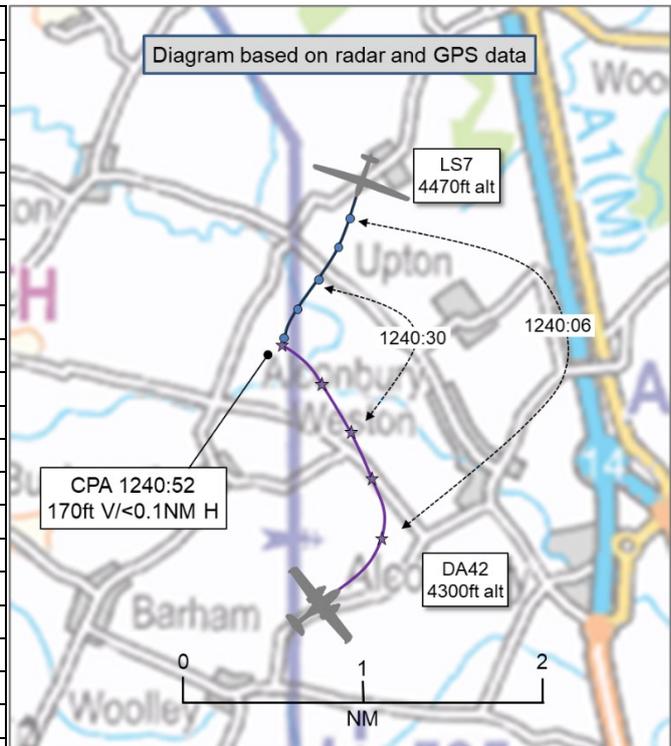
Recorded	Aircraft 1	Aircraft 2
Aircraft	LS7	DA42
Operator	Civ Gld	Civ FW
Airspace	London FIR	London FIR
Class	G	G
Rules	VFR	VFR
Service	None	Basic
Provider	N/A	Cranfield App
Altitude/FL	4470ft	4300ft
Transponder	Not fitted	A, C, S+
<b>Reported</b>		
Colours	White/Red	White
Lighting	Nil	Nav, Strobes
Conditions	VMC	VMC
Visibility	>10km	>10km
Altitude/FL	4700ft	3500ft
Altimeter	QFE	QNH (1018hPa)
Heading	210°	NK°
Speed	75kt	120kt
ACAS/TAS	FLARM	SkyEcho
Alert	None	None
<b>Separation at CPA</b>		
Reported	0ft V/200M H	NK V/NK H
Recorded	170ft V/<0.1NM H
