AIRPROX REPORT No 2023171

Date: 07 Aug 2023 Time: 1310Z Position: 5355N 00025W Location: 3.5NM N Beverley

PART A: SUMMARY OF INFORMATION REPORTED TO UKAB

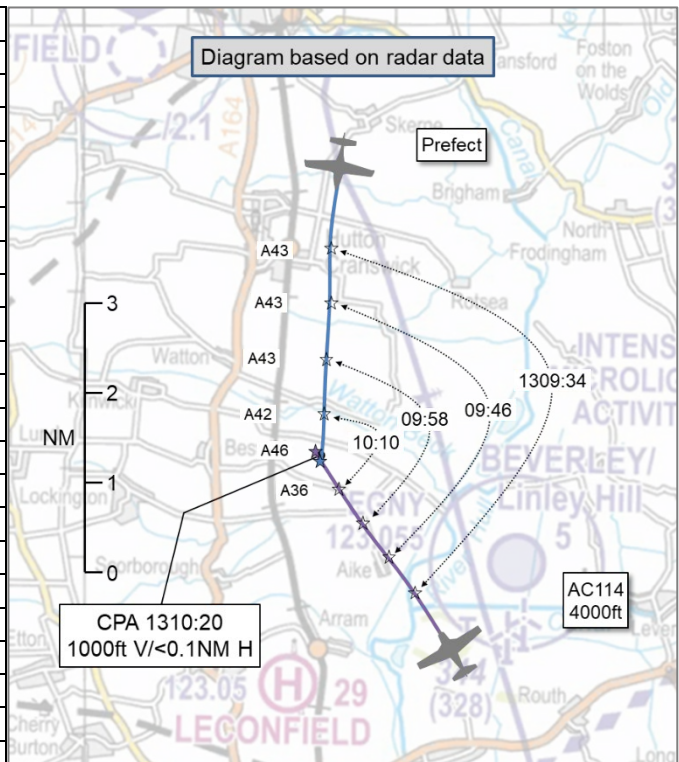
Recorded	Aircraft 1	Aircraft 2
Aircraft	Prefect	AC114
Operator	HQ Air (Trg)	Civ FW
Airspace	London FIR	London FIR
Class	G	G
Rules	VFR	VFR
Service	Traffic	Basic
Provider	Humberside	Humberside
Altitude/FL	4600ft	3600ft
Transponder	A, C, S	A, C, S
Reported		
Colours	Blue/white	White/blue/silver
Lighting	HISL	Anti-col
Conditions	VMC	VMC
Visibility	>10km	>10km
Altitude/FL	4000ft	~4000ft
Altimeter	RPS (NK hPa)	QNH (NK hPa)
Heading	180°	~330°
Speed	180kt	150kt
ACAS/TAS	TAS	TAS
Alert	'Yellow alert'	None
Separation at CPA		
Reported	150ft V/<0.1NM H	NK V/NK H
Recorded	1000ft V/<0.1NM H
