**AIRPROX REPORT No 2023182**

Date: 16 Aug 2023 Time: 1515Z Position: 5302N 00026W Location: Cranwell

**PART A: SUMMARY OF INFORMATION REPORTED TO UKAB**

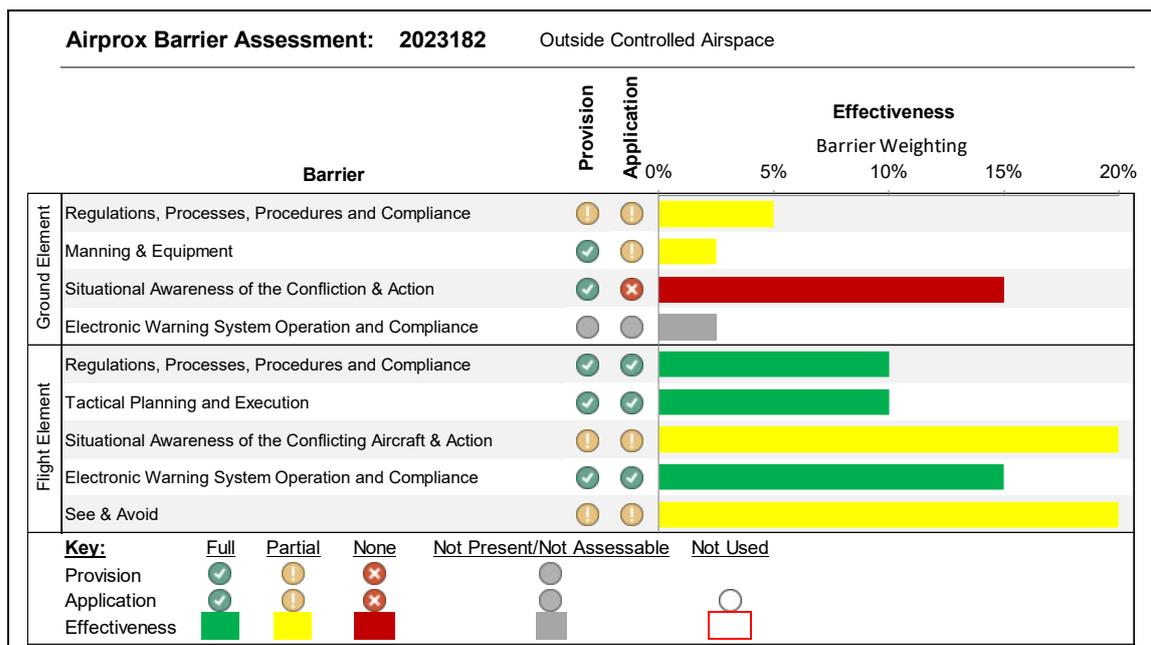
**Situational Awareness of the Conflicting Aircraft and Action** were assessed as **partially effective** because both pilots had generic situational awareness on the position of the other, but the Prefect pilot had not assimilated that the turn across the climb-out lane would conflict with the Phenom.

**See and Avoid** were assessed as **partially effective** because the Phenom pilot saw the Prefect late, but was able to take avoiding action.
