**AIRPROX REPORT No 2023189**

Date: 21 Aug 2023 Time: 1109Z Position: 5213N 00007W Location: 2.5NM N Gransden Lodge

**PART A: SUMMARY OF INFORMATION REPORTED TO UKAB**

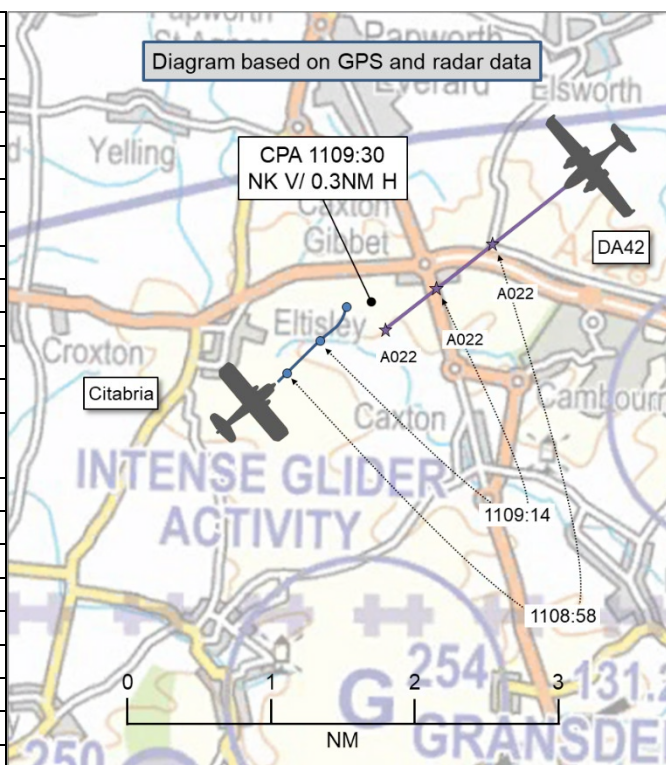
An analysis of the NATS radar replay was undertaken and the DA42 could be positively identified from Mode S data (see Figure 1). The pilot of the glider being towed by the Citabria provided GPS track data for their flight. Although not observed on radar, the location and timings from the GPS track data for the glider (towed by the Citabria until, reportedly, 5sec before CPA) broadly corresponded to a primary-only return seen on radar.

It was by combining the separate data sources that the diagram was constructed and the horizontal separation at CPA determined. The vertical separation at CPA could not be determined. The Citabria and DA42 pilots shared an equal responsibility for collision avoidance and not to operate in such proximity to other aircraft as to create a collision hazard.<sup>2</sup> If the incident geometry is considered as head-on or nearly so then both pilots were required to turn to the right.<sup>3</sup>
