AIRPROX REPORT No 2023261

Date: 05 Dec 2023 Time: ~1532Z Position: 5625N 00324W Location: Perth ATZ

PART A: SUMMARY OF INFORMATION REPORTED TO UKAB

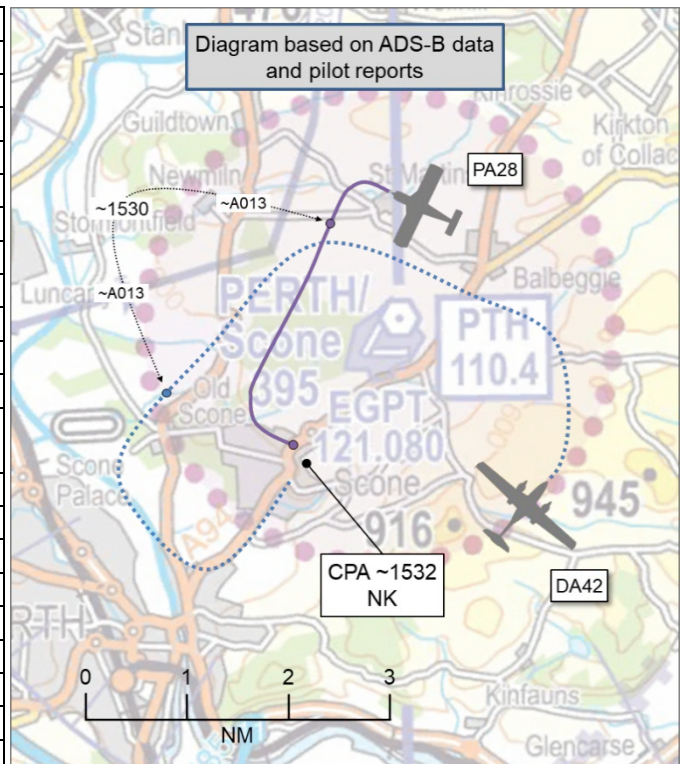
Recorded	Aircraft 1	Aircraft 2
Aircraft	DA42	PA28
Operator	Civ FW	Civ FW
Airspace	Perth ATZ	Perth ATZ
Class	G	G
Rules	VFR	VFR
Service	AGCS	AGCS
Provider	Perth Radio	Perth Radio
Altitude/FL	NK	~890ft
Transponder	A, C, S+	NK
Reported		
Colours	White	White
Lighting	Landing, taxi, position, strobes	Landing, position, strobes
Conditions	VMC	VMC
Visibility	>10km	>10km
Altitude/FL	900ft	1000ft
Altimeter	QNH (1016hPa)	QNH (1016hPa)
Heading	030°	120°
Speed	90kt	70kt
ACAS/TAS	Not fitted	Not fitted
Separation at CPA		
Reported	50ft V/100ft H	100ft V/50m H
Recorded	NK
