**AIRPROX REPORT No 2024143**

Date: 23 Jun 2024 Time: 0915Z Position: 5155N 00118W Location: 5NM NNE of Oxford Kidlington

**PART A: SUMMARY OF INFORMATION REPORTED TO UKAB**

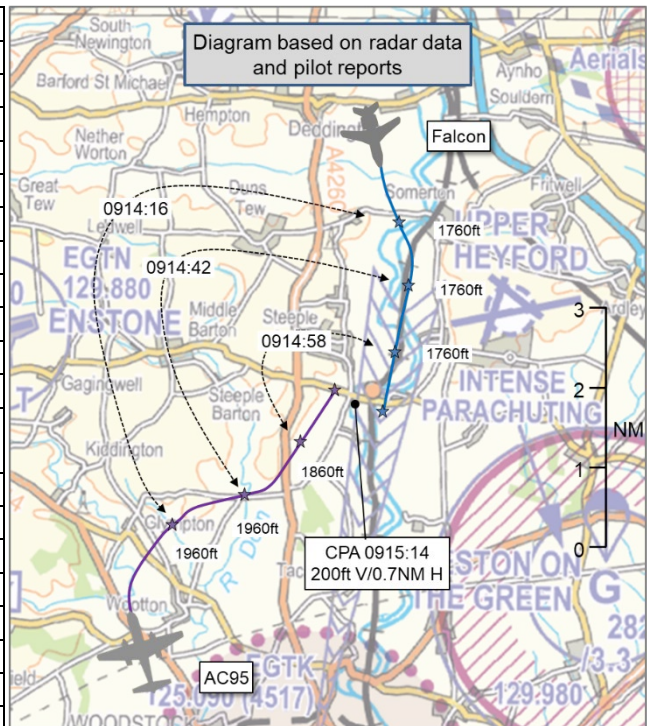
Recorded	Aircraft 1	Aircraft 2
Aircraft	Falcon	AC95
Operator	Civ Comm	Civ Comm
Airspace	London FIR	London FIR
Class	G	G
Rules	IFR	VFR
Service	Traffic	Traffic
Provider	Oxford Radar	Oxford Radar
Altitude/FL	1660ft	1860ft
Transponder	A, C, S	A, C, S
<b>Reported</b>		
Colours	White	White
Lighting	Landing	Anti coll, strobes, navigation
Conditions	VMC	VMC
Visibility	5-10km	>10km
Altitude/FL	1800ft	1700ft
Altimeter	QNH	QNH (1019hPa)
Heading	NK	050°
Speed	NK	190kt
ACAS/TAS	TCAS II	TAS
Alert	RA	Information
<b>Separation at CPA</b>		
Reported	200ft V/NK H	~200ft V/~1NM H
Recorded	200ft V/0.7NM H
