AIRPROX REPORT No 2024223

Date: 28 Aug 2024 Time: 1130Z Position: 5627N 00315W Location: 4NM east of Perth

PART A: SUMMARY OF INFORMATION REPORTED TO UKAB

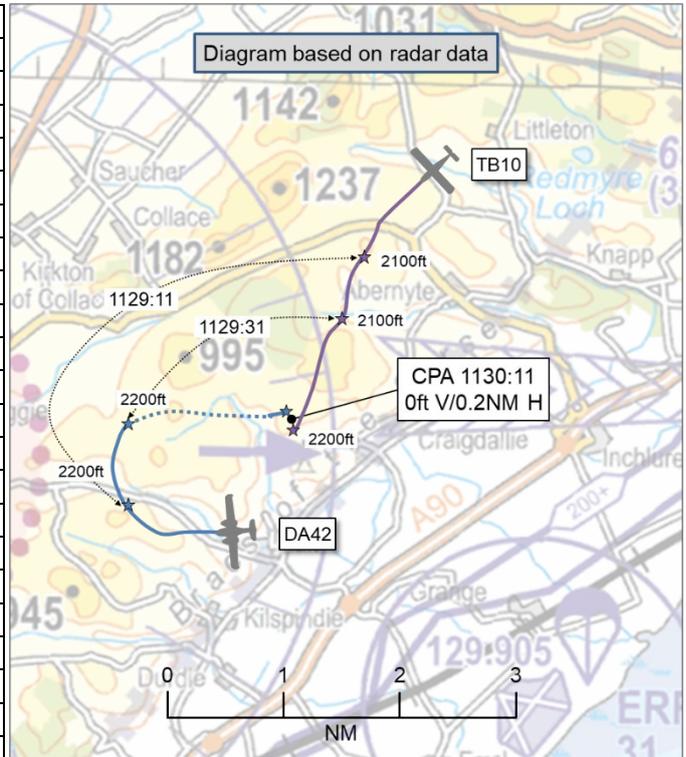
Recorded	Aircraft 1	Aircraft 2
Aircraft	DA42	TB10
Operator	Civ FW	Civ FW
Airspace	Scottish FIR	Scottish FIR
Class	G	G
Rules	VFR	VFR
Service	Basic	Basic
Provider	Dundee Approach	Scottish Information
Altitude/FL	2200ft	2200ft
Transponder	A, C, S	A, C, S
Reported		
Colours	White	Yellow/Blue
Lighting	Standard	Anti-collision
Conditions	VMC	VMC
Visibility	>10km	>10km
Altitude/FL	2000ft	2000ft
Altimeter	QNH	QNH
Heading	NK	190°
Speed	110kt	120kt
ACAS/TAS	TAS	Not fitted
Alert	Alert	N/A
Separation at CPA		
Reported	100ft V/<1NM H	0ft V/1000m H
Recorded	0ft V/0.2NM H
