**AIRPROX REPORT No 2024235**

Date: 13 Sep 2024 Time: 1209Z Position: 5115N 00108W Location: Basingstoke

**PART A: SUMMARY OF INFORMATION REPORTED TO UKAB**

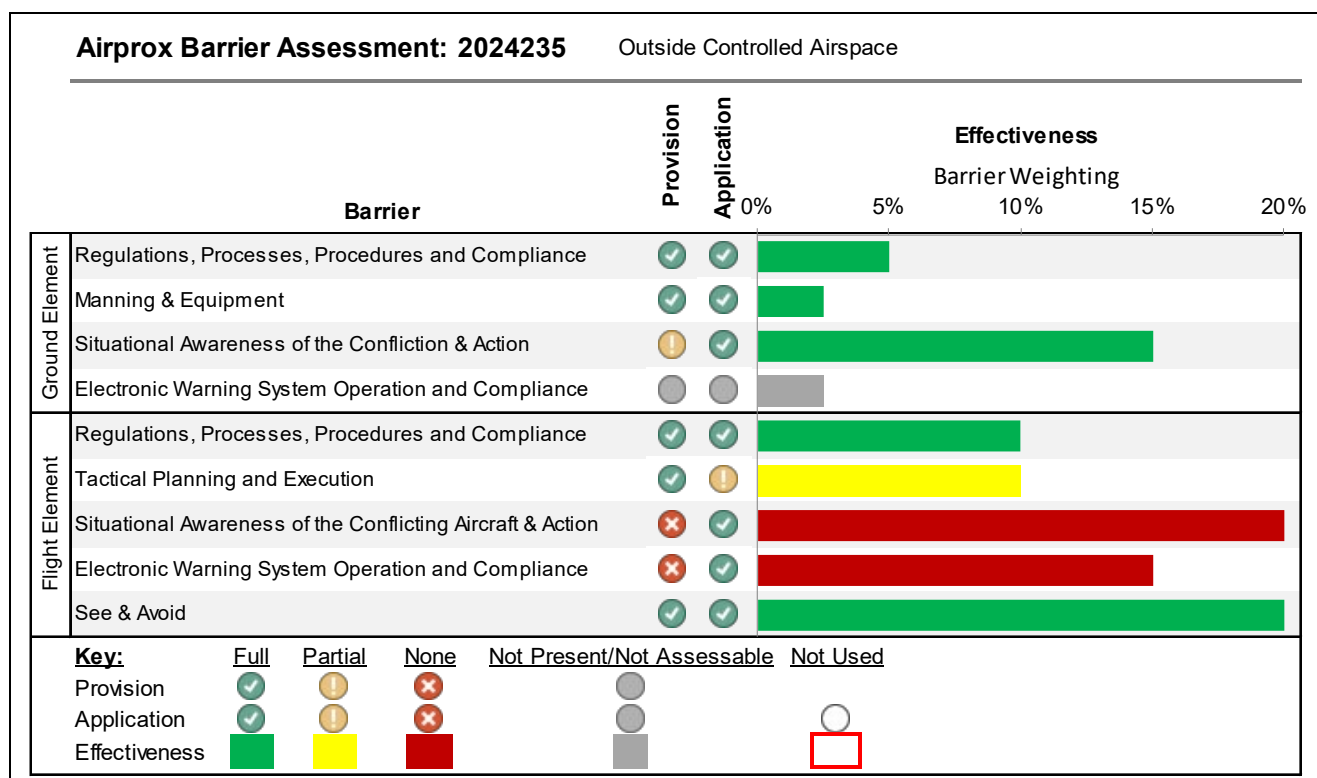
**Situational Awareness of the Conflicting Aircraft and Action** were assessed as **ineffective** because the pilot of the ASW27 had not had situational awareness of the presence of the Apache until it had been visually acquired.

**Electronic Warning System Operation and Compliance** were assessed as **ineffective** because the EC equipment fitted to the ASW27 would not have been expected to have detected the presence of the Apache.
