**AIRPROX REPORT No 2024239**

Date: 20 Sep 2024 Time: 1454Z Position: 5302N 00030W Location: Cranwell ATZ

**PART A: SUMMARY OF INFORMATION REPORTED TO UKAB**

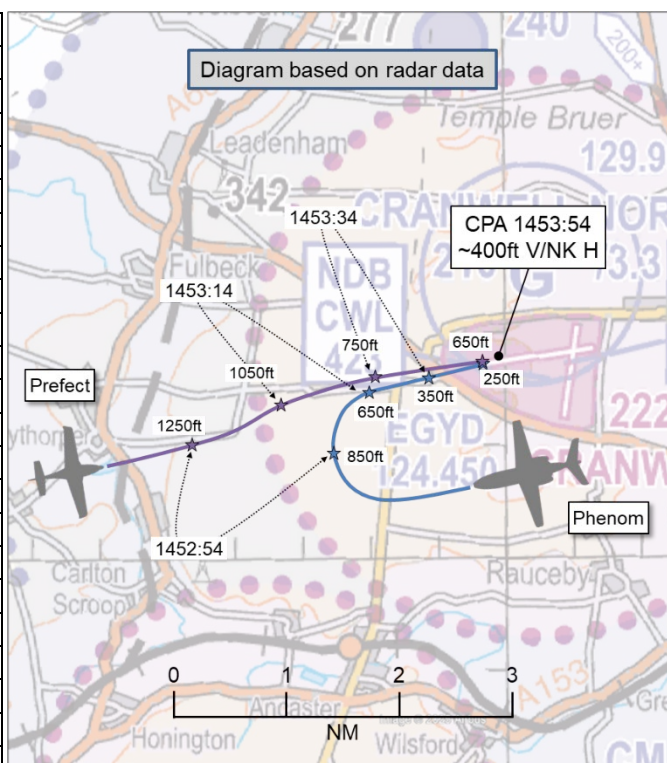
**THE PHENOM PILOT** reports that they were conducting circuits at Cranwell on RW08RH when a formation of three Prefects joined for the break. During the final turn, the trainee in the left-hand seat [of the Phenom] was visual with the formation. As [the Phenom pilot] commenced their touch-and-go, they heard [Formation callsign-1] call that they were on the break. As [the Phenom] rotated and passed 100-200ft, they saw a Prefect to the left, slightly above and ahead of them, presumably at 500ft. They called for their trainee to level, which they did at about 200ft and, once they were both confident it was the third Prefect and they were clear, they continued the climb.

[The pilot of the Phenom commented that] it takes about 7sec for a Phenom to conduct a touch and go. There were three Prefects in the formation, conducting a break at 5sec intervals. They have raised this as an Airprox because they believed if they hadn't intervened, the distance between the aircraft would have been significantly closer. They also spoke with [Formation callsign-3] who, due to being number three in the formation, was aware that there was a Phenom in the circuit conducting a touch-and-go but, [reportedly], wasn't visual with it during their break.
