AIRPROX REPORT No 2024246

Date: 28 Sep 2024 Time: 1126Z Position: 5109N 00103W Location: 2.5NM SSW Lasham

PART A: SUMMARY OF INFORMATION REPORTED TO UKAB

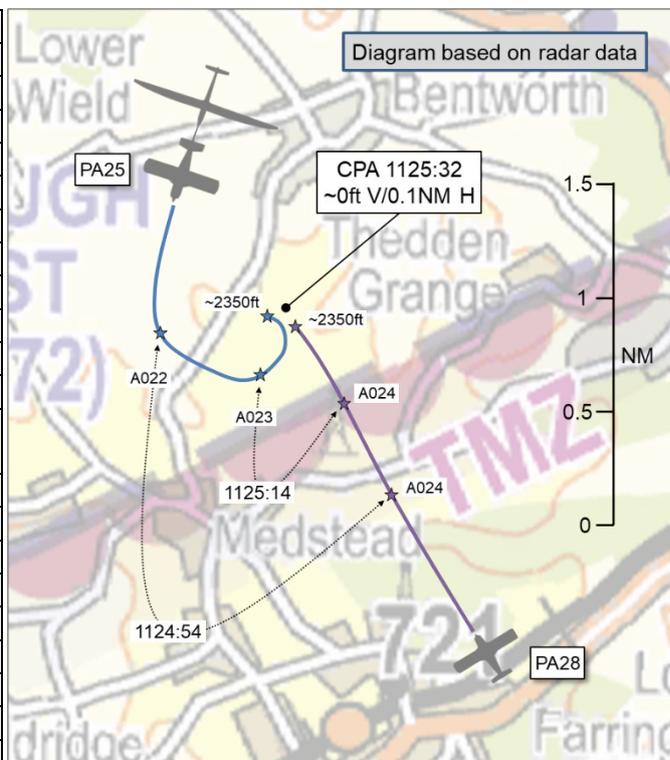
Recorded	Aircraft 1	Aircraft 2
Aircraft	PA25	PA28
Operator	Civ FW	Civ FW
Airspace	London FIR	London FIR
Class	G	G
Rules	VFR	VFR
Service	Listening Out	Basic
Provider	Lasham Gliders	Farnboro' LARS W
Altitude/FL	~2350ft	~2350ft
Transponder	A, C, S	A, C, S
Reported		
Colours	Yellow	White
Lighting	Nav, strobe, beacon, landing	Landing, taxi, beacon
Conditions	VMC	VMC
Visibility	>10km	>10km
Altitude/FL	1700ft	2300ft
Altimeter	QFE (1005hPa)	NR
Heading	100°	329°
Speed	70kt	90kt
ACAS/TAS	FLARM	Other
Alert	None	None
Separation at CPA		
Reported	0ft V/350m H	0m V/200m H
Recorded	~0ft V/0.1NM H
