AIRPROX REPORT No 2024247

Date: 28 Sep 2024 Time: 1225Z Position: 5118N 00051W Location: Blackbushe circuit

PART A: SUMMARY OF INFORMATION REPORTED TO UKAB

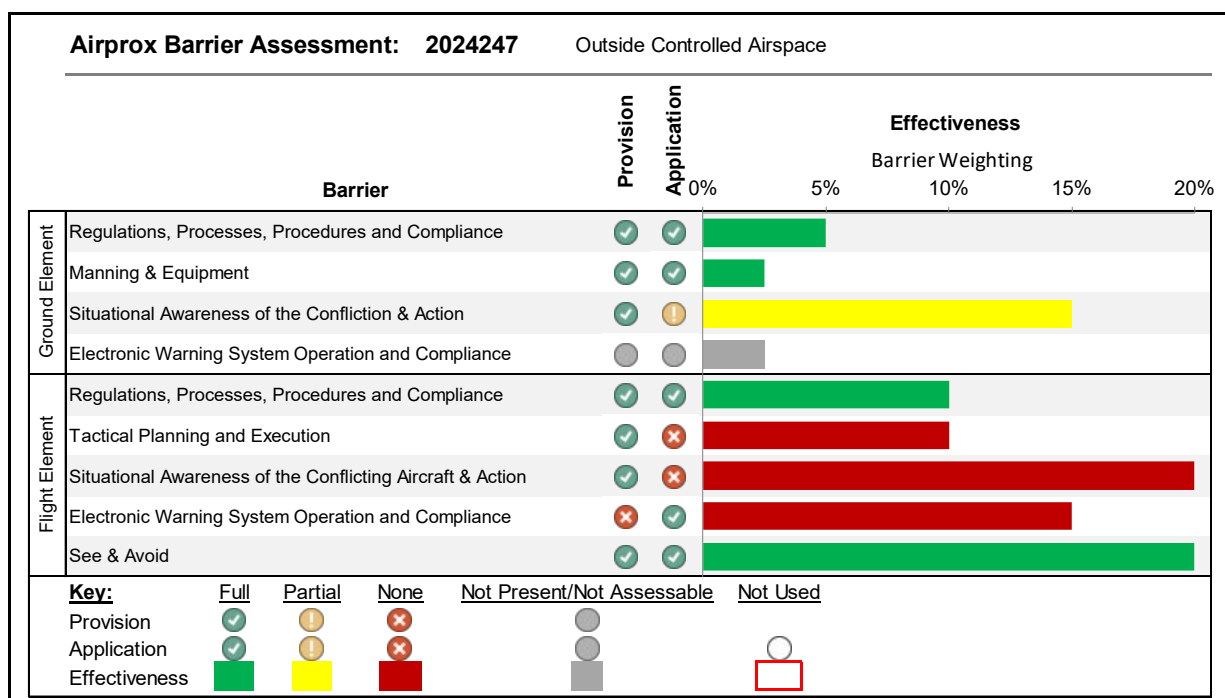
Situational Awareness of the Conflicting Aircraft and Action were assessed as **ineffective** because the RV9 pilot did not sufficiently integrate with the PA28 despite having situational awareness of the presence of the aircraft and sighting it on climbout.

Electronic Warning System Operation and Compliance were assessed as **ineffective** because the PA28's electronic conspicuity equipment was unable to detect any emissions from the RV9.
