AIRPROX REPORT No 2024249

Date: 02 Oct 2024 Time: 1131Z Position: 5414N 00109W Location: 1NM NNE of Sutton Bank

PART A: SUMMARY OF INFORMATION REPORTED TO UKAB

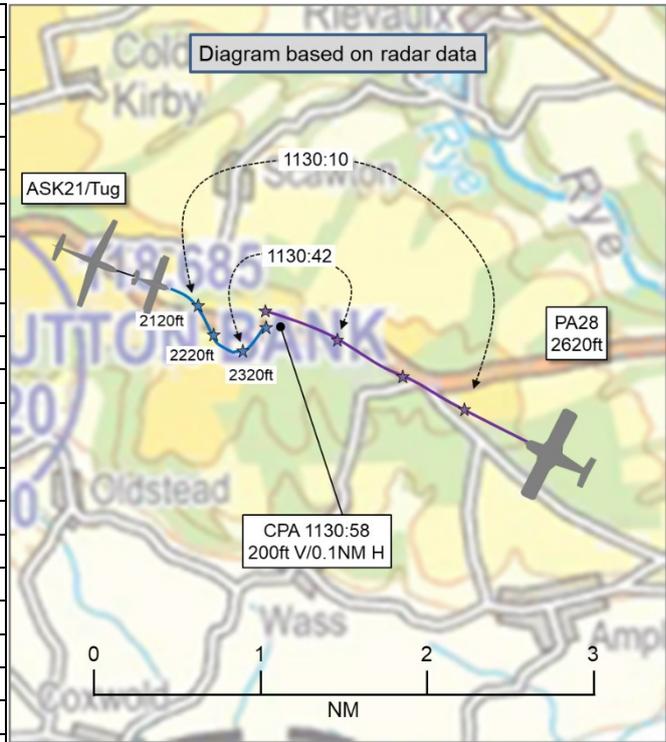
Recorded	Aircraft 1	Aircraft 2
Aircraft	ASK21	PA28
Operator	Civ Gld	Civ FW
Airspace	London FIR	London FIR
Class	G	G
Rules	VFR	VFR
Service	None	Basic
Provider	N/A	Teesside
Altitude/FL	2420ft	2620ft
Transponder	A, C, S ¹	A, C, S
Reported		
Colours	White and red	Blue and white
Lighting	Nil	Landing, taxi, nav, HISL, strobes, bcn
Conditions	VMC	VMC
Visibility	>10km	>10km
Altitude/FL	~1500ft	2500ft
Altimeter	QFE	RPS
Heading	~030°	300°
Speed	~60kt	90kt
ACAS/TAS	FLARM	Not fitted
Alert	None	N/A
Separation at CPA		
Reported	200ft V/<0.5NM H	500ft V/1km H
Recorded	200ft V/0.1NM H

They had first sighted the PA28 when they were at approximately 1500ft QFE and 1NM NNE of Sutton Bank whilst being towed by the club's Eurofox tug. It was in their 2 o'clock at less than 1NM and slightly higher, tracking east-to-west. Their first contact reaction/assessment was that [the 2 aircraft] were converging and climbing in such a way that a risk of collision had to be determined by observing how they had been closing for a further short space of time i.e. a few seconds. As the ASK21 pilot was doing this, they advised their front seat handling P2 of the contact and continued to apportion time between monitoring their performance and positioning with the tug and the ongoing closure of the other aircraft. The ASK21 pilot did not feel the need to take over the handling as their P2 was an experienced pilot and they had mentally prepared a takeover reaction plan if they felt there was a need for its execution. In this regard, the ASK21 pilot's thoughts were that they would execute this plan immediately upon determining a risk of collision was probable, but with sufficient time to ensure successful execution. At the same time as they had been strategizing, they observed the tug deviate left by about 10-20° and lower the nose of the tug to flatten the climb profile. That immediately allowed the ASK21 pilot to judge that there had been no risk of collision unless either the tug or the PA28 did something to bring them closer. The ASK21 pilot had kept their eyes on the PA28 and saw it pass right-to-left in front and above them, such that they had been able to read its registration from both its lower wing and rear fuselage. The ASK21 pilot reports that they did not at any time see the PA28 alter height or track and it passed them continuing to track west.
