AIRPROX REPORT No 2024250

Date: 29 Sep 2024 Time: 1156Z Position: 5109N 00102W Location: 2NM S Lasham

PART A: SUMMARY OF INFORMATION REPORTED TO UKAB

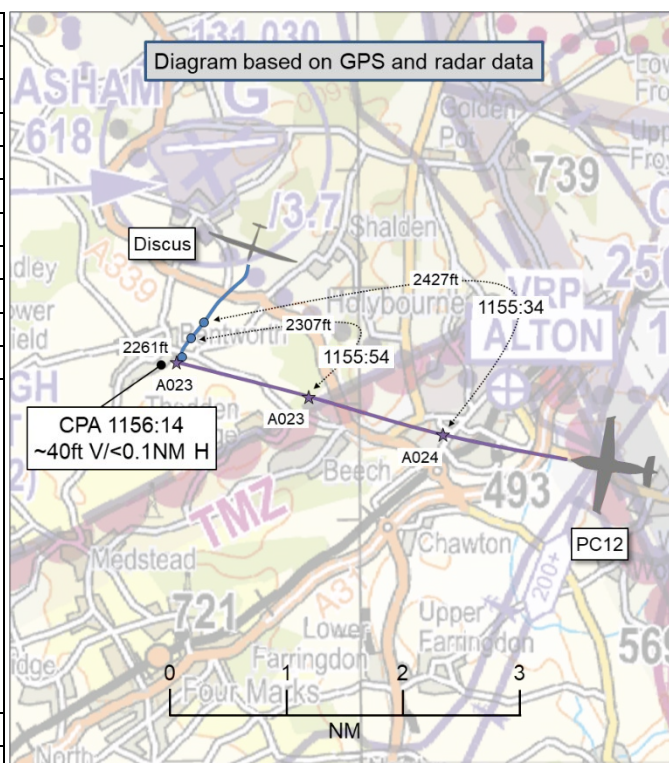
Recorded	Aircraft 1	Aircraft 2
Aircraft	Discus	PC12
Operator	Civ Gld	Civ FW
Airspace	London FIR	London FIR
Class	G	G
Rules	VFR	VFR
Service	Listening Out	Traffic
Provider	Lasham Gliders	Farnboro' LARS W
Altitude/FL	2261ft	A023
Transponder	Not fitted	A, C, S+
Reported		
Colours	White	Not Reported
Lighting	None	
Conditions	VMC	
Visibility	>10km	
Altitude/FL	1700ft	
Altimeter	QFE	
Heading	220°	
Speed	45kt	
ACAS/TAS	FLARM	
Alert	None	
Separation at CPA		
Reported	0ft V/0.4NM H	NR
Recorded	~40ft V/<0.1NM H

THE DISCUS PILOT reports that they were launched by aero-tow from Lasham airfield to 2000ft AGL. They were released at 1148:35 just north-west of Alton. At 1155, they were flying straight-and-level with a heading of 220°, pointing into wind. At 1156, a grey-coloured powered-plane, [the PC12], was at the same height and, with low horizontal separation, passed by at high speed. It was moving from left-to-right. They took avoiding action by making a sharp left turn.
