**AIRPROX REPORT No 2024251**

Date: 03 Oct 2024 Time: 1155Z Position: 5154N 00210W Location: Gloucestershire Airport

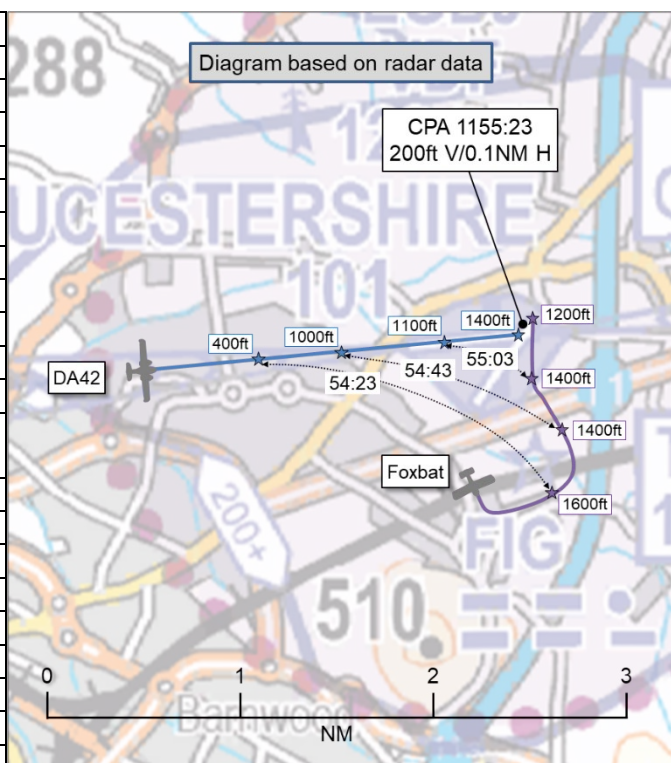
| Recorded | Aircraft 1 | Aircraft 2 |
|---|---|---|
| Recorded | 200ft V/0.1NM H | |

**THE DA42 PILOT** reports that, while on a simulated asymmetric approach with an MEIR student under the hood, they were cleared for a low approach and go-around on RW09 at Gloucestershire. A Foxbat aircraft [callsign] was cleared to join overhead and descend downwind, but instructed to report before turning crosswind due to traffic on final (them). They were visual with the aircraft as it joined overhead, the [pilot of the] aircraft did not comply with the ATC join restriction and proceeded to fly onto the crosswind leg in front of them as they commenced the go-around. This resulted in them having to take control of the aircraft to commence a two engine go-around to climb and turn clear of the aircraft. Due to the [clear] conditions they believed that the chance of a collision was very low, as they were aware of the aircraft for the duration of its join and they had maintained visual contact. However, they did have to alter their flightpath to avoid a collision.
