AIRPROX REPORT No 2024254

Date: 05 Oct 2024 Time: 1404Z Position: 5213N 00137W Location: Wellesbourne RW18 Final

PART A: SUMMARY OF INFORMATION REPORTED TO UKAB

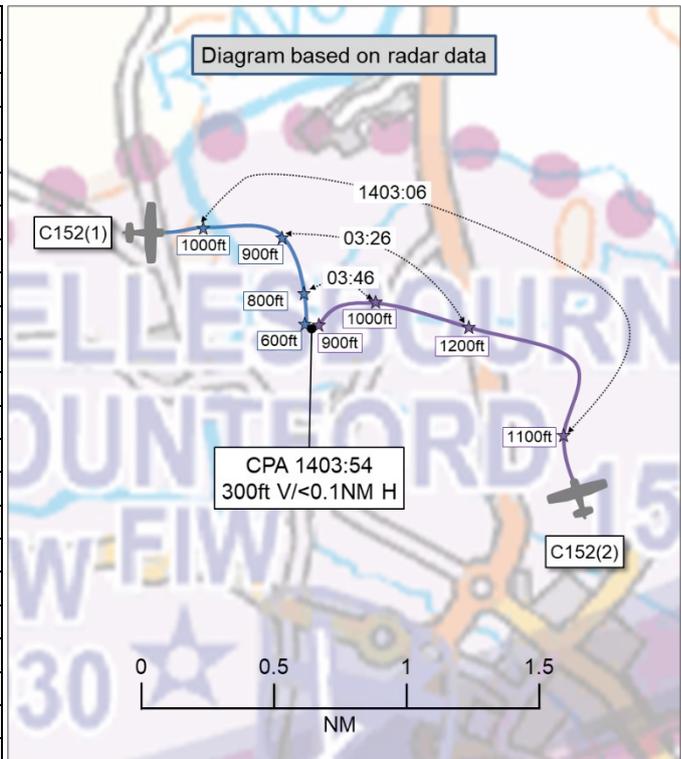
Recorded	Aircraft 1	Aircraft 2
Aircraft	C152(1)	C152(2)
Operator	Civ FW	Civ FW
Airspace	Wellesbourne ATZ	Wellesbourne ATZ
Class	G	G
Rules	VFR	VFR
Service	AFIS	AFIS
Provider	Wellesbourne Info	Wellesbourne Info
Altitude/FL	600ft	900ft
Transponder	A, C, S	A, C, S+
Reported		
Colours	White/Red	White/Blue
Lighting	Bcn, nav, landing	Nav & strobes
Conditions	VMC	VMC
Visibility	>10km	>10km
Altitude/FL	650ft	900ft
Altimeter	QFE (1008hPa)	QFE
Heading	180°	270°
Speed	70kt	65kt
ACAS/TAS	PilotAware	Not fitted
Alert	None	N/A
Separation at CPA		
Reported	0ft V/150m H	0ft V/0.25NM H
Recorded	300ft V/<0.1NM H
