AIRPROX REPORT No 2024259

Date: 13 Oct 2024 Time: 1152Z Position: 5058N 00057W Location: 2NM SW of Petersfield

PART A: SUMMARY OF INFORMATION REPORTED TO UKAB

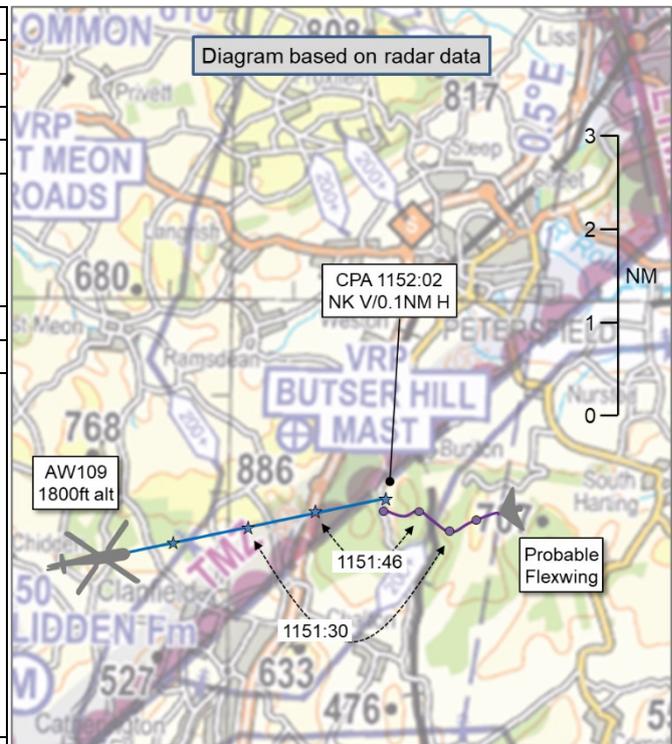
THE AW109 PILOT reports a late spot of a Flexwing as it passed below and slightly to their left. The AW109 pilot had requested a Traffic Service from Farnborough Radar who were very busy and hadn't come back to them [at that time]. The Flexwing was somewhat masked in amongst the ground clutter beneath them, and the pilot had been aware of two TAS contacts which they had been trying to identify [and] which might have reduced their lookout closer to the aircraft. The AW109 pilot did not believe the aircraft had a transponder as approximately 15sec after they had passed the Flexwing they were given a reduced Traffic Service and no mention was made of the contact by the controller. The AW109 pilot noted that they can't say for certain if the Flexwing [pilot] had seen their aircraft but it appeared to be manoeuvring as they had passed it, possibly to increase separation.
