AIRPROX REPORT No 2024261

Date: 13 Oct 2024 Time: 0958Z Position: 5157N 00135W Location: 1.5NM NW Chipping Norton

PART A: SUMMARY OF INFORMATION REPORTED TO UKAB

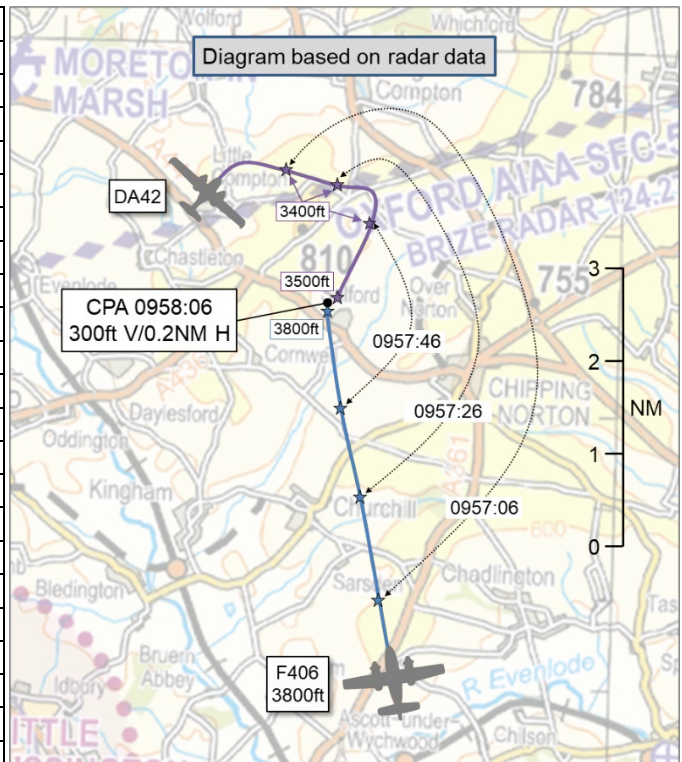
Recorded	Aircraft 1	Aircraft 2
Aircraft	F406	DA42
Operator	Civ Comm	Civ FW
Airspace	London FIR	London FIR
Class	G	G
Rules	VFR	VFR
Service	Traffic	Basic
Provider	Birmingham Radar	Brize Radar
Altitude/FL	3800ft	3500ft
Transponder	A, C, S	A, C, S+
Reported		
Colours	White and red	White
Lighting	Anti colls, nav, bcn	Nav, anti-colls, ldg
Conditions	VMC	VMC
Visibility	>10km	>10km
Altitude/FL	3800ft	3500ft manoeuvring
Altimeter	QNH	QNH
Heading	360°	NK
Speed	180kt	120kt
ACAS/TAS	SkyEcho	TAS & SkyEcho
Alert	Unknown	None
Separation at CPA		
Reported	100ft V/100m H	Not seen
Recorded	300ft V/0.2NM H
