**AIRPROX REPORT No 2024265**

Date: 17 Oct 2024 Time: 1526Z Position: 5416N 00146W Location: IVO East Witton

**PART A: SUMMARY OF INFORMATION REPORTED TO UKAB**

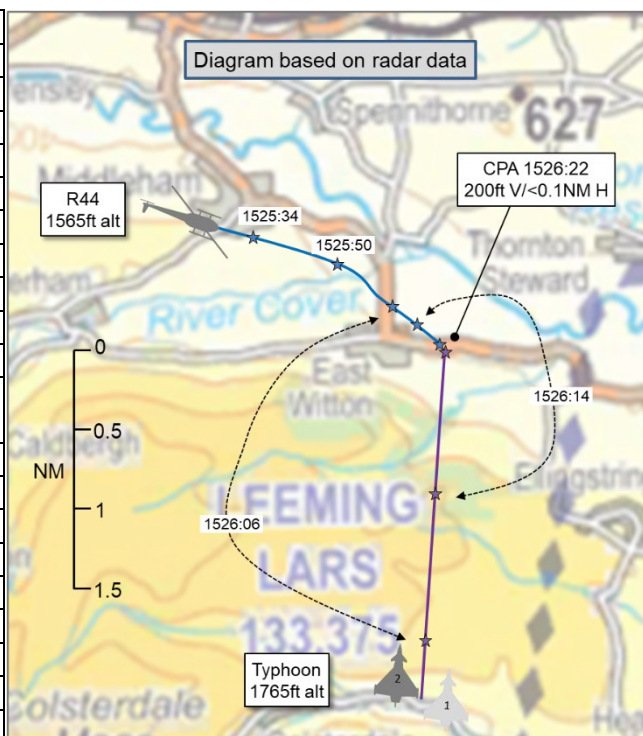
Recorded	Aircraft 1	Aircraft 2
Aircraft	R44	Typhoon
Operator	Civ Helo	HQ Air (Ops)
Airspace	London FIR	London FIR
Class	G	G
Rules	VFR	VFR
Service	Basic	Listening Out
Provider	Leeming Zone	LL Common
Altitude/FL	1565ft	1765ft
Transponder	A, C, S	A, C, S
Reported		
Colours	Grey with red stripe	Grey
Lighting	Nav, strobes	NR
Conditions	VMC	VMC
Visibility	>10km	>10km
Altitude/FL	1700ft	1500ft
Altimeter	NR	NR
Heading	090°	005°
Speed	90kt	420kt
ACAS/TAS	Not fitted	Not fitted
Alert	N/A	None
Separation at CPA		
Reported	75ft V/100m H	200ft V/NR H
Recorded	200ft V/<0.1NM H
