AIRPROX REPORT No 2024269

Date: 05 Oct 2024 Time: 1111Z Position: 5206N 00021W Location: 14NM north of Luton Airport

PART A: SUMMARY OF INFORMATION REPORTED TO UKAB

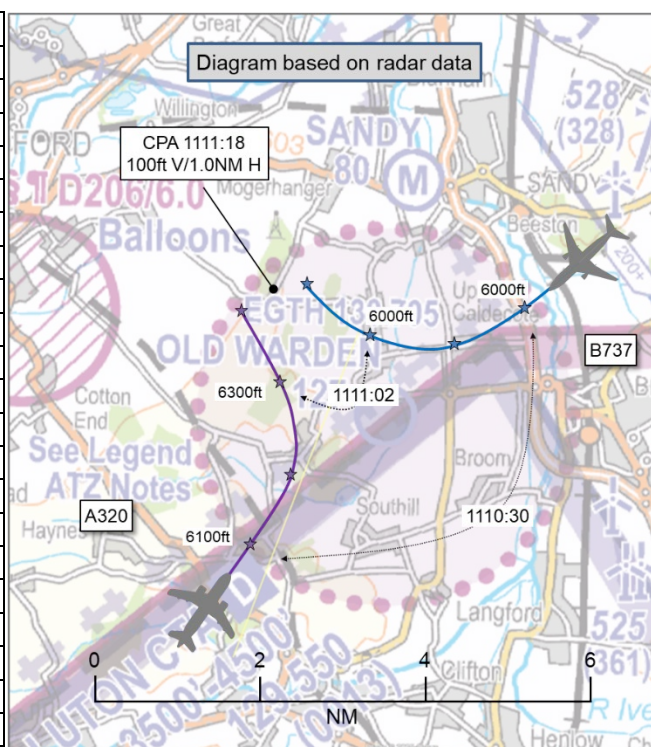
Recorded	Aircraft 1	Aircraft 2
Aircraft	B737	A320
Operator	CAT	CAT
Airspace	London TMA	London TMA
Class	A	A
Rules	IFR	IFR
Service	Radar Control	Radar Control
Provider	Luton Approach	TC North West
Altitude/FL	6100ft	6200ft
Transponder	A, C, S+	A, C, S+
Reported		
Colours	Company	Company
Lighting	Standard	Standard
Conditions	VMC	VMC
Altitude/FL	6000ft	6000ft
Altimeter	QNH	QNH
Heading	230°	NR
Speed	220kt	NR
ACAS/TAS	TCAS II	TCAS II
Alert	RA	RA
Separation at CPA		
Reported	0ft V/NK H	0ft V/NK H
Recorded	100ft V/1.0NM H
