AIRPROX REPORT No 2024274

Date: 12 Nov 2024 Time: 1425Z Position: 5205N 00102W Location: 1NM SW Silverstone

PART A: SUMMARY OF INFORMATION REPORTED TO UKAB

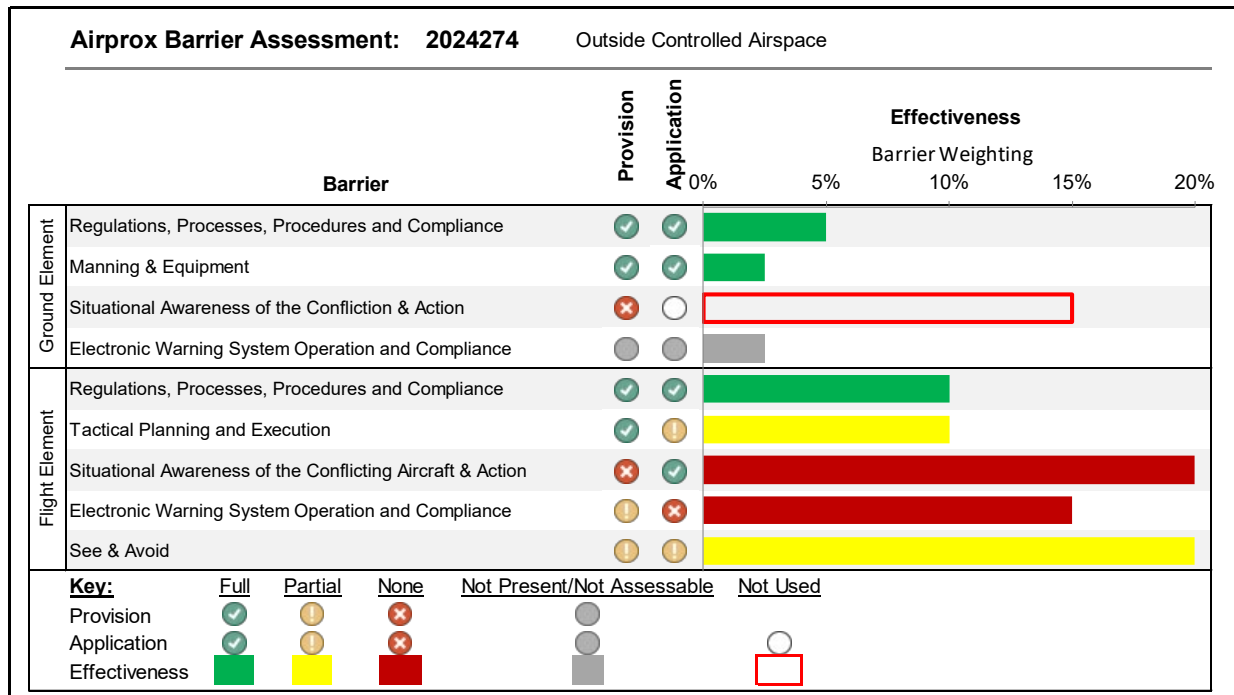
Electronic Warning System Operation and Compliance were assessed as **ineffective** because PA28(1)'s electronic conspicuity equipment, capable of detecting emissions from the PA28(2)'s transponder, had not alerted them to the PA28(2)'s presence.

See and Avoid were assessed as **partially effective** because both pilots had sighted the other aircraft at a late stage.
