AIRPROX REPORT No 2024277

Date: 17 Nov 2024 Time: 1202Z Position: 5213N 00137W Location: Wellesbourne ATZ

PART A: SUMMARY OF INFORMATION REPORTED TO UKAB

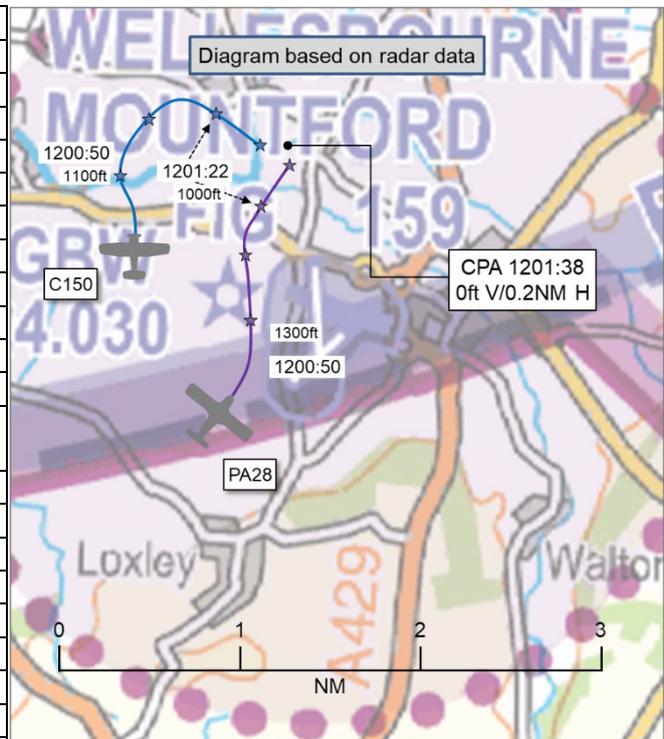
Recorded	Aircraft 1	Aircraft 2
Aircraft	C150	PA28
Operator	Civ FW	Civ FW
Airspace	Wellesbourne ATZ	Wellesbourne ATZ
Class	G	G
Rules	VFR	VFR
Service	AFIS	AFIS
Provider	Wellesbourne	Wellesbourne
Altitude/FL	1000ft	1000ft
Transponder	A, C, S	A, C, S
Reported		
Colours	White and blue	White and blue
Lighting	Beacon, strobes, navigation	Beacon
Conditions	VMC	VMC
Visibility	>10km	>10km
Altitude/FL	1000ft	1000ft
Altimeter	QNH (1015hPa)	QFE
Heading	100°	360°
Speed	NK	90kt
ACAS/TAS	Not fitted	Not fitted
Separation at CPA		
Reported	0ft V/100m H	0ft V/0m H
Recorded	0ft V/0.2NM H

THE C150 PILOT reports that they had been in the circuit with their student when they turned onto base leg heading 100°. When they had reached approximately 1000ft QNH still on the base leg, they had seen the PA28 coming toward them (heading 360°) at the same altitude, above RW18 threshold. According to the Wellesbourne AFISO, the PA28 was ahead of the C150 on downwind, but for some reason they appeared to be going towards the north. The C150 pilot had to turn left to avoid the PA28 and initiated a left-hand orbit outside the ATZ.

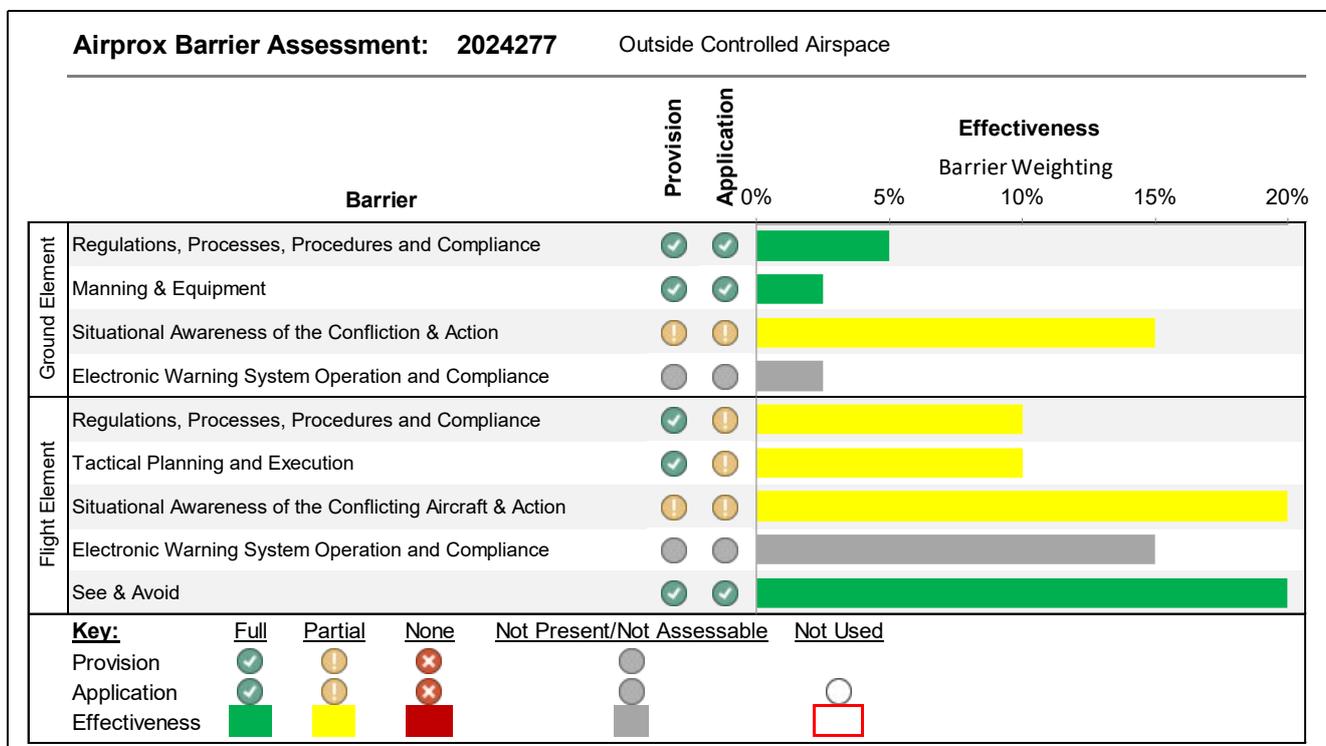
Tactical Planning and Execution was assessed as **partially effective** because the PA28 pilot, having made a non-standard join, did not then conform with the pattern of traffic as formed by the C150 pilot.

Situational Awareness of the Conflicting Aircraft and Action were assessed as **partially effective** because the C150 pilot had gained only generic situational awareness of the position of the PA28.
