AIRPROX REPORT No 2024278

Date: 14 Nov 2024 Time: ~1808Z Position: 5115N 00136W Location: Ludgershall

PART A: SUMMARY OF INFORMATION REPORTED TO UKAB

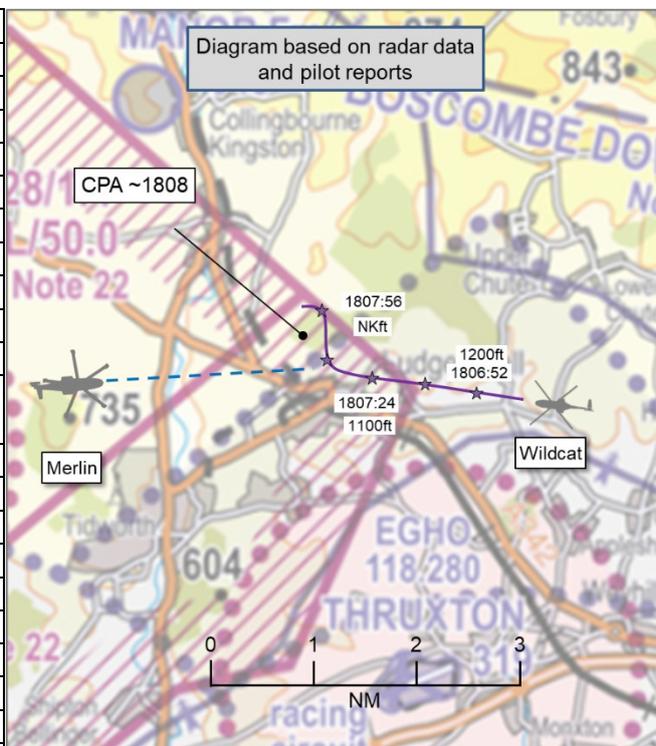
Recorded	Aircraft 1	Aircraft 2
Aircraft	Merlin	Wildcat
Operator	HQ JAC	HQ JAC
Airspace	EGD126	EGD126
Class	Danger Area	Danger Area
Rules	VFR	VFR
Service	Basic	Basic
Provider	Salisbury Info	Salisbury Info
Altitude/FL	NK	NK
Transponder	None ¹	A, C, S
Reported		
Lighting	Strobes Upper Red	NR
Conditions	VMC	VMC
Visibility	>10km	>10km
Altitude/FL	100ft AGL	~500ft AGL
Heading	West	Holding
Speed	100kt	NR
ACAS/TAS	TAS	NR
Alert	Alert	NR
Separation at CPA		
Reported	0ft V/200m H	NR
Recorded	NK

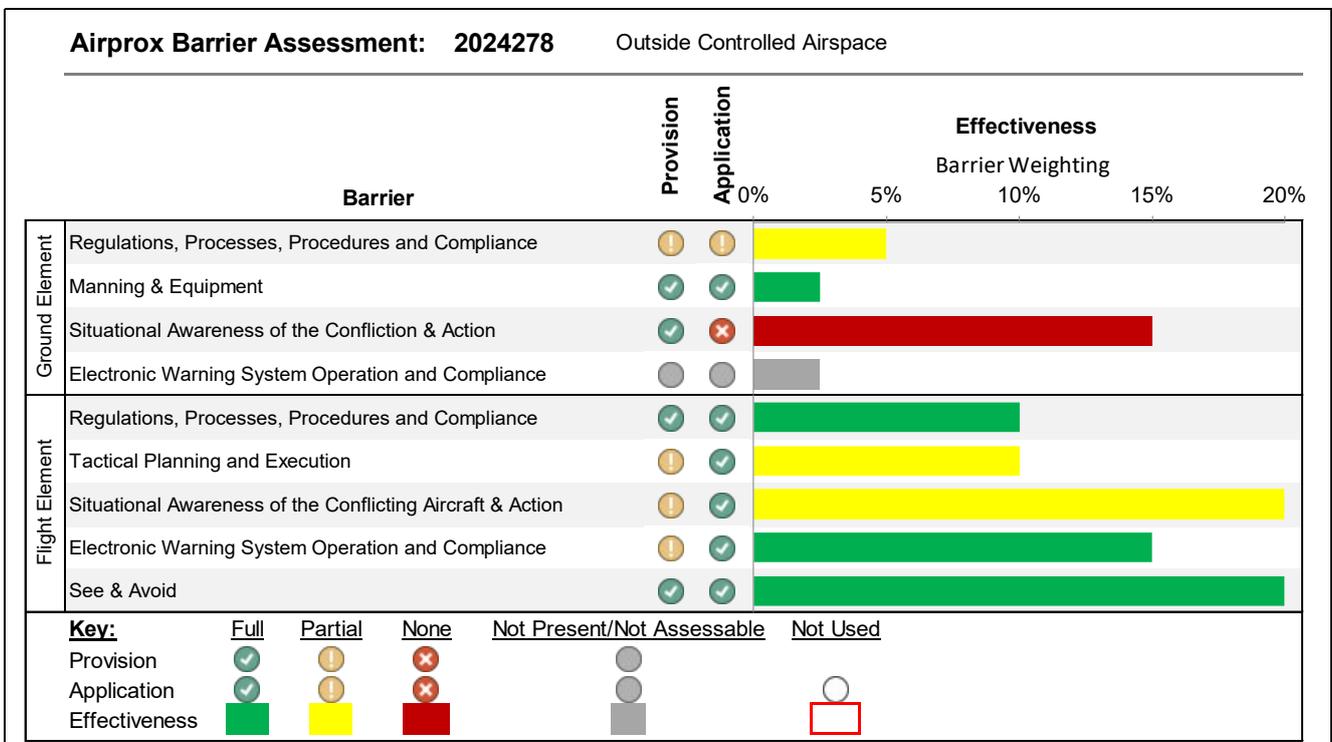
Tactical Planning and Execution was assessed as **partially effective** because the SPTA orders had been ambiguous.

Situational Awareness of the Conflicting Aircraft and Action were assessed as **partially effective** because the Wildcat pilot had no situational awareness of the presence of the Merlin, and the Merlin pilot had generic situational awareness of the presence of the Wildcat.
