**AIRPROX REPORT No 2024285**

Date: 22 Nov 2024 Time: 1352Z Position: 5154N 00210W Location: Gloucestershire Airport

**PART A: SUMMARY OF INFORMATION REPORTED TO UKAB**

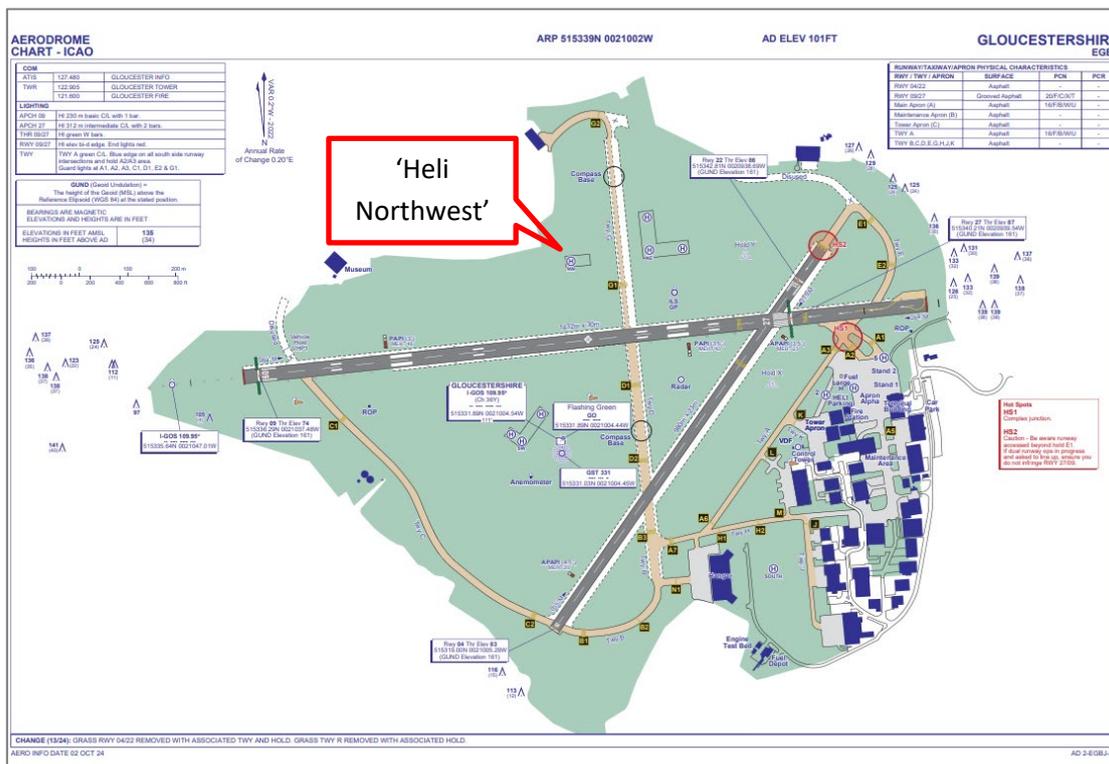
Figure 1 Gloucestershire Aerodrome Chart

The 'Heli Northwest' referred to is represented on the Gloucestershire Aerodrome Chart (Figure 1).
