**AIRPROX REPORT No 2025014**

Date: 13 Feb 2025 Time: 1142Z Position: 5121N 00114W Location: 4.5NM Southeast of Newbury

**PART A: SUMMARY OF INFORMATION REPORTED TO UKAB**

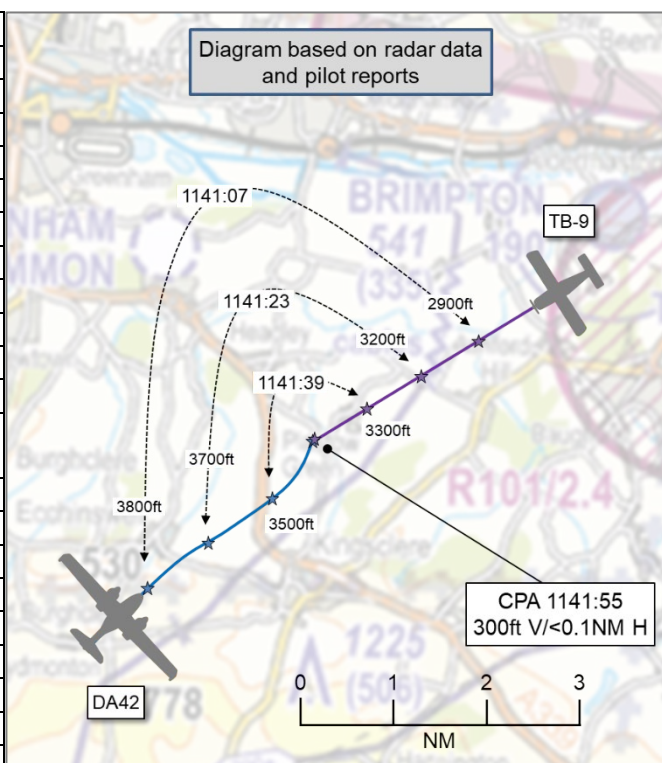
Recorded	Aircraft 1	Aircraft 2
Aircraft	DA42	TB-9
Operator	Civ FW	Civ FW
Airspace	London FIR	London FIR
Class	G	G
Rules	IFR	IFR
Service	Traffic	Traffic
Provider	Farnboro' LARS W	Farnboro' LARS W
Altitude/FL	3300ft	3600ft
Transponder	A, C, S+	A, C, S
Reported		
Colours	White	Blue and white
Lighting	Nav, landing, strobe	Strobes
Conditions	IMC	IMC
Visibility	<5km	<5km
Altitude/FL	3000ft	2800ft
Altimeter	QNH (1022hPa)	QNH (1022hPa)
Heading	050°	235°
Speed	140kt	105kt
ACAS/TAS	TAS	PilotAware
Alert	TA	None
Separation at CPA		
Reported	0-200ft V/0.5NM H	Not seen
Recorded	300ft V/<0.1NM H
