**AIRPROX REPORT No 2025063**

Date: 29 Apr 2025 Time: 1335Z Position: 5319N 00056W Location: Retford/Gamston ATZ

**PART A: SUMMARY OF INFORMATION REPORTED TO UKAB**

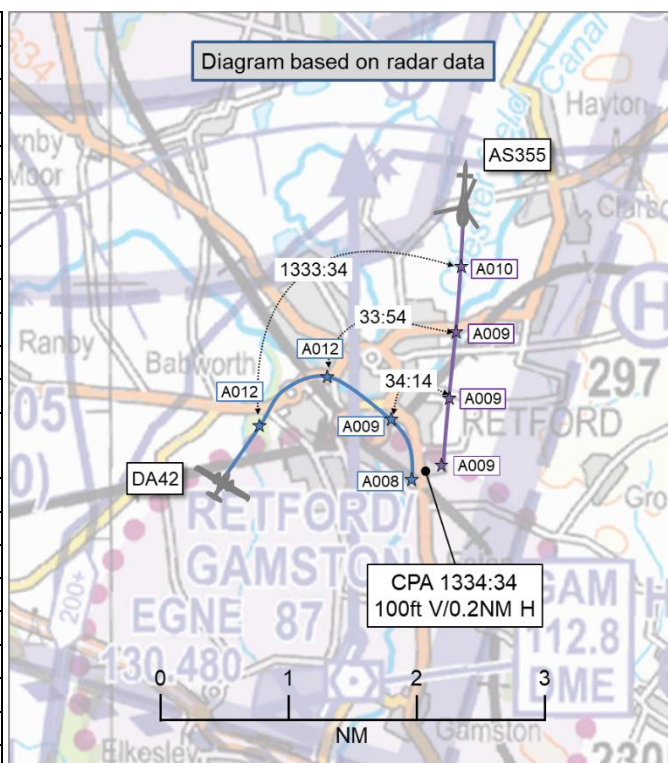
| Recorded | Aircraft 1 | Aircraft 2 |
|---|---|---|
| Reported | 0ft V/200m H | 0ft V/100m H |
| Recorded | 100ft V/0.2NM H | |
