AIRPROX REPORT No 2025071

Date: 01 May 2025 Time: 1500Z Position: 5202N 00215W Location: 2NM SW Upton-upon-Severn

PART A: SUMMARY OF INFORMATION REPORTED TO UKAB

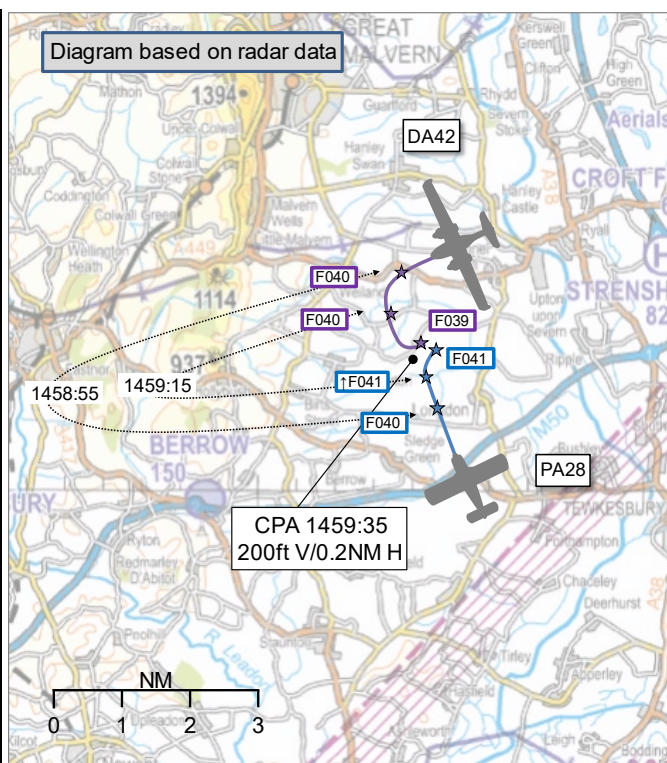
Recorded	Aircraft 1	Aircraft 2
Aircraft	PA28	DA42
Operator	Civ FW	Civ FW
Airspace	London FIR	London FIR
Class	G	G
Rules	VFR	VFR
Service	Basic	Basic
Provider	London Info	Gloucester
Altitude/FL	FL041	FL039
Transponder	A, C, S	A, C, S+
Reported		
Colours	Blue/White	White
Lighting	'Full'	Strobes
Conditions	VMC	VMC
Visibility	>10km	>10km
Altitude/FL	4000ft	4000ft
Altimeter	QNH (1014hPa)	QNH
Heading	330°	300°
Speed	100kt	120kt
ACAS/TAS	Not fitted	Other
Alert	N/A	Information
Separation at CPA		
Reported	100ft V/7-800m H	100ft V/0.25NM H
Recorded	200ft V/0.2NM H
