**AIRPROX REPORT No 2025115**

Date: 20 Jun 2025 Time: 1116Z Position: 5232N 00054W Location: 7NM SE of Leicester Aerodrome

**PART A: SUMMARY OF INFORMATION REPORTED TO UKAB**

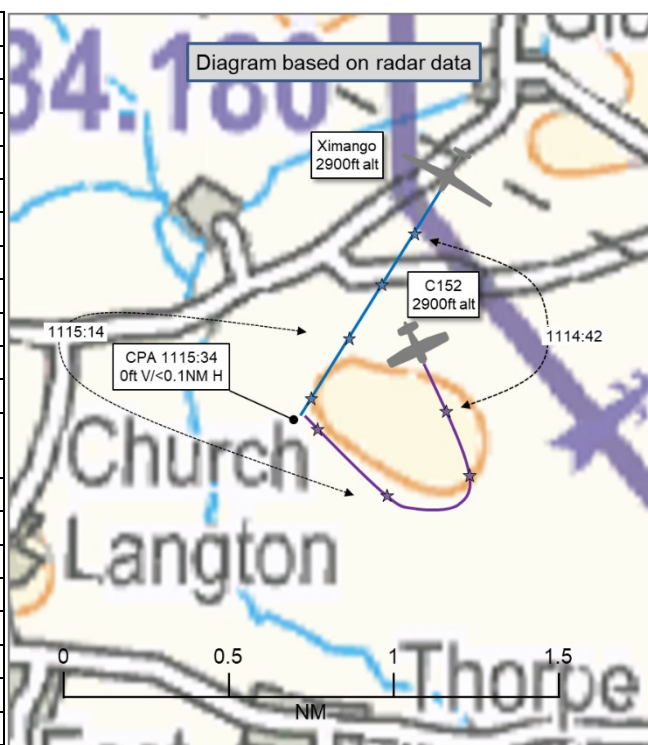
Recorded	Aircraft 1	Aircraft 2
Aircraft	Ximango	C152
Operator	Civ FW	Civ FW
Airspace	London FIR	London FIR
Class	G	G
Rules	VFR	VFR
Service	None	Listening Out
Provider	N/A	Leicester Radio
Altitude/FL	2900ft	2900ft
Transponder	A, C, S	A, C, S
<b>Reported</b>		
Colours	White	White, orange
Lighting	Strobe	Landing, taxi, navigation, beacon
Conditions	VMC	VMC
Visibility	>10km	>10km
Altitude/FL	~2600ft	3000ft
Altimeter	QNH (1025hPa)	QNH
Heading	211°	360°
Speed	~60kt	90kt
ACAS/TAS	PowerFLARM	Not fitted
Alert	None	N/A
<b>Separation at CPA</b>		
Reported	0ft V/300m H	0ft V/100m H
Recorded	0ft V/<0.1NM H
