AIRPROX REPORT No 2025098

Date: 23 May 2025 Time: 1208Z Position: 5206N 00130W Location: IVO Edgehill/Shenington

PART A: SUMMARY OF INFORMATION REPORTED TO UKAB

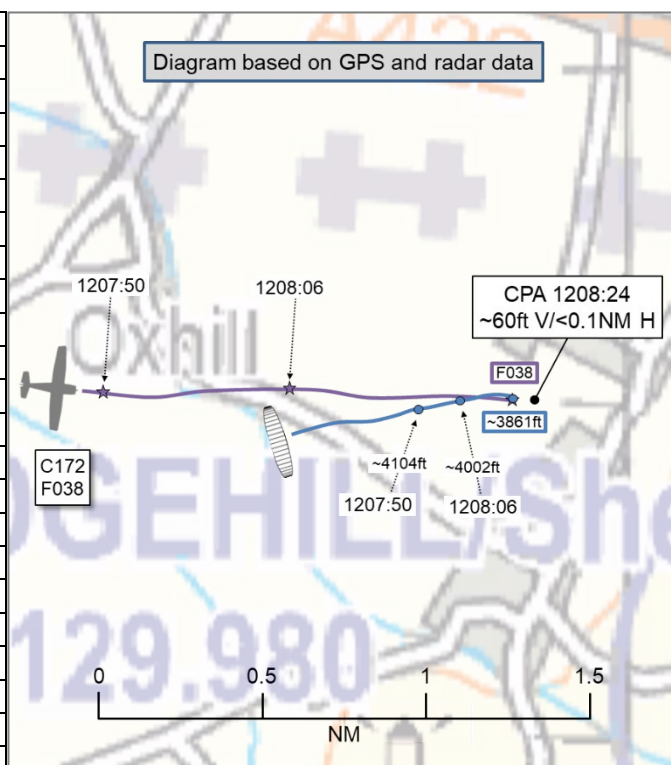
An analysis of the NATS radar replay was undertaken and the C172 could be positively identified from Mode S data (Figure 1). The paraglider was not observed on the replay.
