AIRPROX REPORT No 2025116

Date: 16 Jun 2025 Time: 1555Z Position: 5411N 00121W Location: Topcliffe

PART A: SUMMARY OF INFORMATION REPORTED TO UKAB

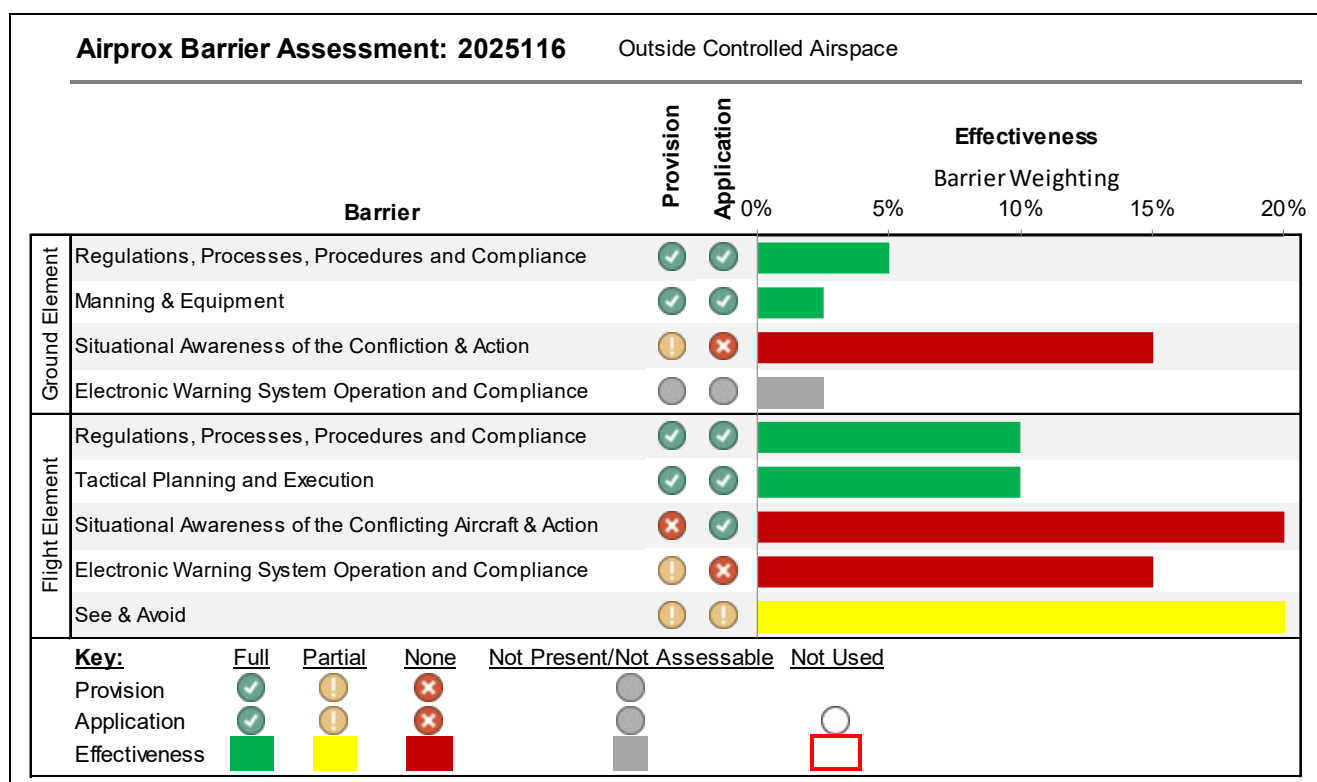
Electronic Warning System Operation and Compliance were assessed as **ineffective** because the equipment carried by the Kestrel had been unable to receive any electronic emissions from the BE200, and that carried by the BE200 had not registered any electronic emissions from the Kestrel.

See and Avoid were assessed as **partially effective** because the Kestrel pilot had seen the BE200 only in time to enable late avoiding action and the BE200 pilot had seen the Kestrel after it had passed through their 12 o'clock.
