AIRPROX REPORT No 2025125

Date: 27 Jun 2025 Time: 1623Z Position: 5110N 00101E Location: 5NM E Ashford

PART A: SUMMARY OF INFORMATION REPORTED TO UKAB

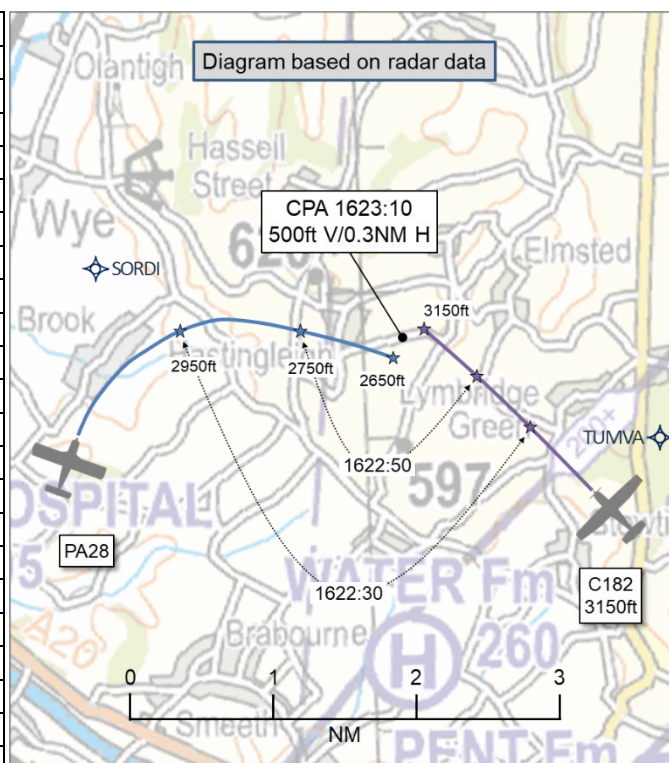
Recorded	Aircraft 1	Aircraft 2
Aircraft	PA28	C182
Operator	Civ FW	Civ FW
Airspace	London FIR	London FIR
Class	G	G
Rules	IFR	NR
Service	Procedural	None
Provider	Lydd	N/A
Altitude/FL	2650ft	3150ft
Transponder	A, C, S	A, C, S
Reported		
Colours	Burgundy, white	NR
Lighting	Anti-col, landing	Strobes, taxi, Indg
Conditions	IMC	VMC ¹
Visibility	<5km	NR
Altitude/FL	2700ft	3200ft
Altimeter	QNH (1023hPa)	QNH (1024hPa)
Heading	108°	NR
Speed	120kt	NR
ACAS/TAS	PilotAware	Other
Alert	TA	None
Separation at CPA		
Reported	"Not seen"	300ft V/0.5NM H
Recorded		500ft V/0.3NM H

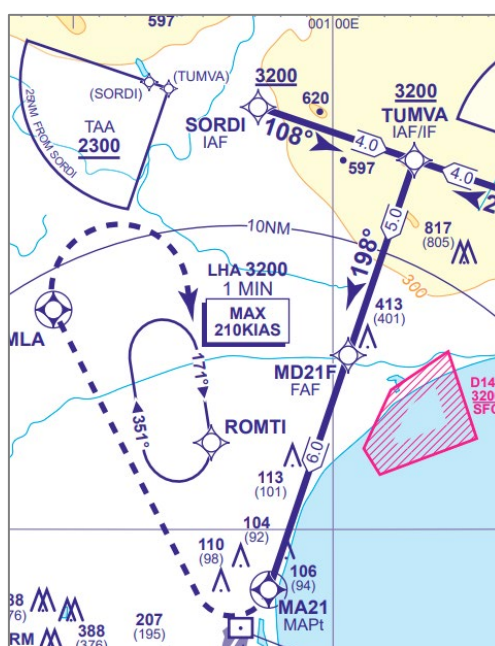
Figure 3 (UK AIP AD 2. EGMD-8-3)

The UK AIP provides the following instrument approach chart for RNP Y RW21 at Lydd:

Members next noted that Lydd aerodrome is depicted on VFR navigational charts with 'feathers' denoting the presence of at least one Instrument Approach Procedure. The length of the feather symbol itself does not indicate a range to which the IAP extends. Members felt that it would be highly likely that aircraft being flown to the procedure may be encountered in the vicinity of the aerodrome. Therefore, members considered it wise for a pilot transiting nearby to gather situational awareness of any traffic that may affect their flight. Indeed, it was noted that VFR navigational charts provide a 'strong recommendation' that pilots contact the ATSU in question when flying within 10NM of the aerodrome in question. It was noted that the pilot of the C182 had not been in receipt of a service at the time of the Airprox and, even though they had flown no closer than approximately 13NM from Lydd during their flight, members agreed that it would still have been prudent to have contacted the Lydd controller for a service or, at least, to have relayed their intentions as they passed through the area. Indeed, CAP 774, Ch.5, Procedural Service 5.1 provides the following guidance:

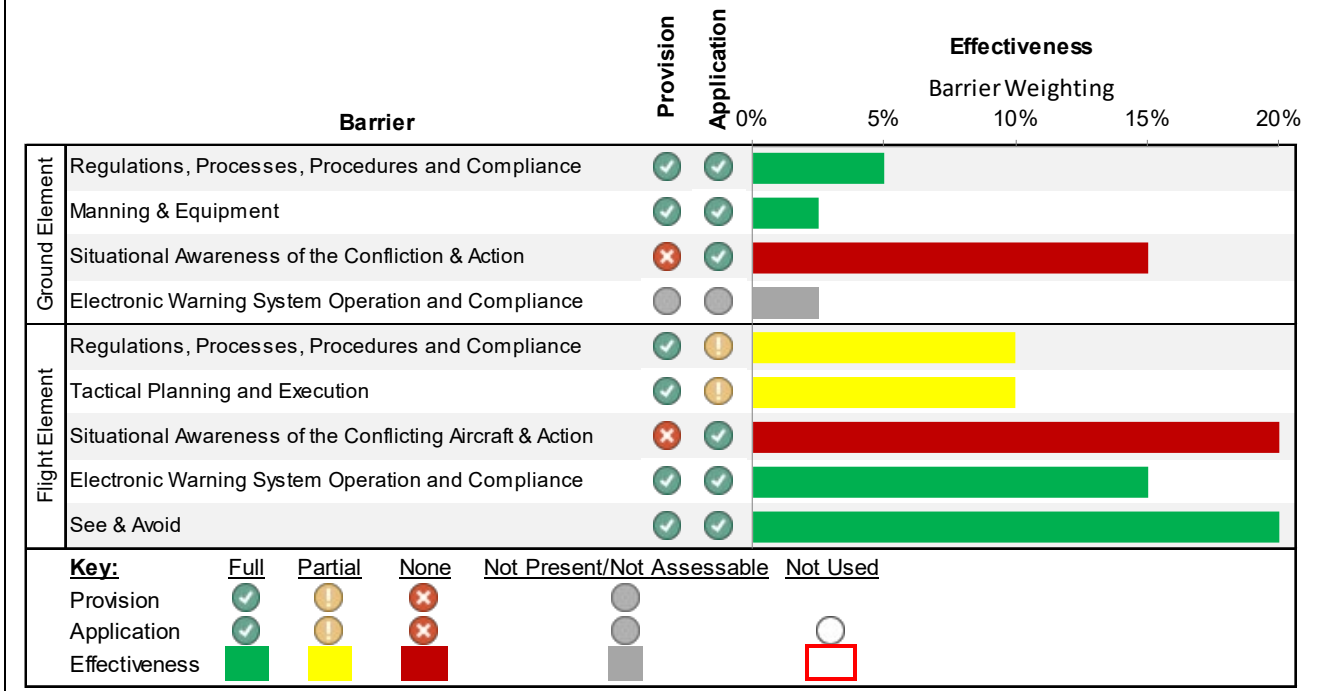
Airprox Barrier Assessment: 2025125

Outside Controlled Airspace
