AIRPROX REPORT No 2025127

Date: 29 Jun 2025 Time: 1002Z Position: 5120N 00004W Location: 1.5NM NNW Kenley Airfield

PART A: SUMMARY OF INFORMATION REPORTED TO UKAB

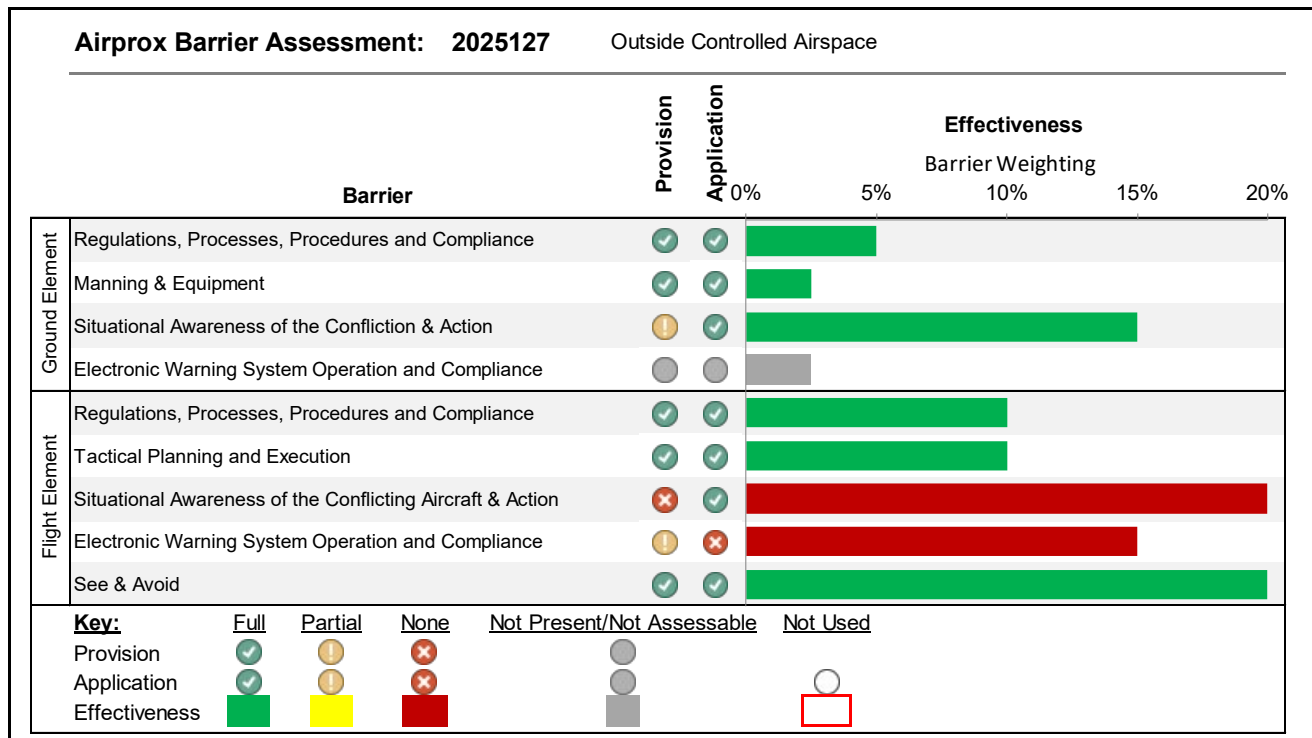
Situational Awareness of the Conflicting Aircraft and Action were assessed as **ineffective** because Viking pilot had no situational awareness of the position of the TB20, and the TB20 pilot had only generic situational awareness of the potential for glider activity in the vicinity of Kenley.

Electronic Warning System Operation and Compliance were assessed as **ineffective** because the first of the EC equipment fitted in the Viking could not detect that of the TB20, and detections by its second EC equipment were not being exploited. Additionally, the EC equipment in the TB20 did not alert as expected.
