AIRPROX REPORT No 2025135

Date: 03 Jul 2025 Time: ~1202Z Position: 5058N 00113W Location: IVO Lower Upham

PART A: SUMMARY OF INFORMATION REPORTED TO UKAB

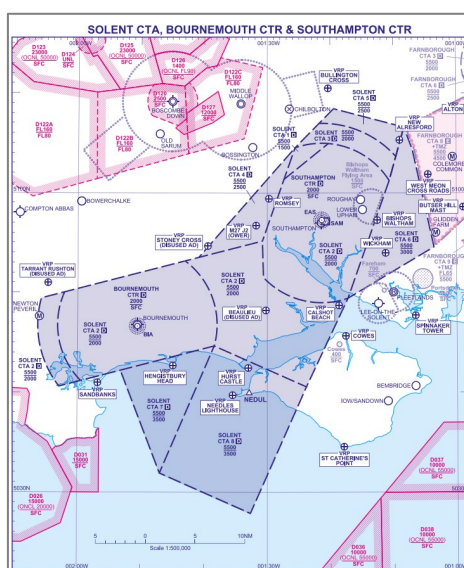
Figure 1

UK AIP ENR 6-38

Southampton Airport is situated inside controlled airspace, consisting of an Aerodrome Traffic Zone (ATZ) and Control Zone (CTR), both Class D [airspace], from the surface to 2000ft AMSL. Above this is the Solent Control Area (CTA) which is Class D [airspace] from 2000ft to 5500ft. The airspace is only active during the airport's hours of operation. Both VFR and IFR flights are permitted, while above 5500ft the airspace is Class A, with only IFR flights permitted and is permanently active (see UK AIP entry at Figure 1).

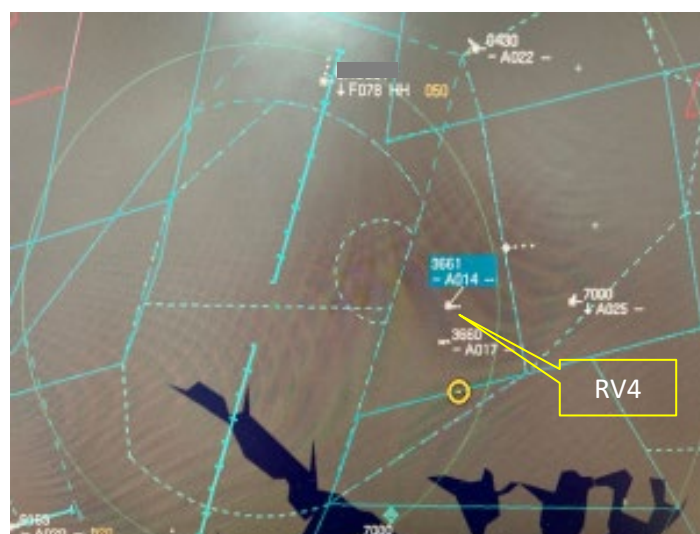
Figure 5

1159:56 [ATCO A] [RV4 C/S], *cleared to join controlled airspace, left-base join for runway 20, QNH of 1029.*

1200:04 [RV4] *Cleared to enter controlled airspace, 1029, er for left base 20, [C/S].*

ATCO A called Tower to pass information on [the RV4], a further aircraft was heard in the background.

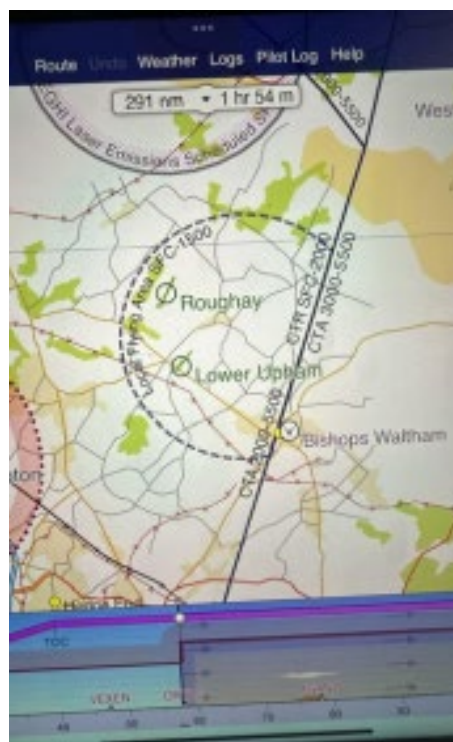
Figure 11

It was noted that SkyDemon flight planning navigation software depicted the BWFA as:
