AIRPROX REPORT No 2025141

Date: 08 Jul 2025 Time: ~1152Z Position: 5026N 00446W Location: ivo of Roche airstrip

PART A: SUMMARY OF INFORMATION REPORTED TO UKAB

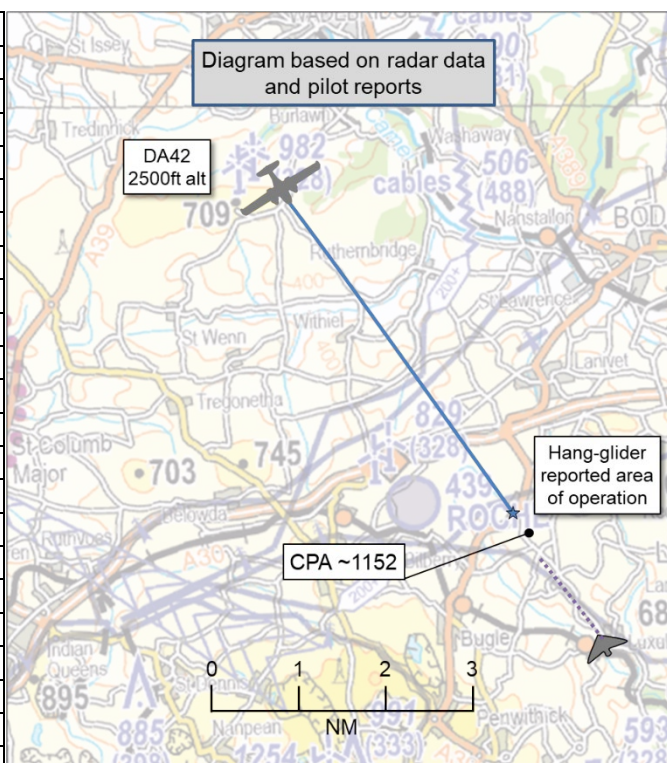
THE NEWQUAY RADAR CONTROLLER reports that [the DA42] was being vectored from the north of the aerodrome for an ILS approach to RW30. While on the downwind leg (130°) at an altitude of 2500ft on Newquay QNH (1022hPa at the time), the pilot reported deviating from their clearance to avoid collision with a hang-glider, observed from their cockpit at the same level, in their 12 o'clock heading in the opposite direction. There were no radar returns, primary or secondary, observed on the situation display at any point before or after the report from the pilot on frequency, and the presence of this unknown aircraft was completely unknown to them as the Radar controller. As far as they could see, there were no aircraft showing in the immediate area of [the DA42] as they were on the downwind leg of the pattern. [The DA42 pilot] was under a Traffic Service at the time of the report. Once [the DA42 pilot] reported they were clear and happy to continue vectors. they turned onto base leg and continued to land safely at Newquay via the ILS on RW30.

They talked to the pilot the next day on the telephone to ask for more details on what had happened, and [the pilot] confirmed seeing what looked like a hang-glider, dark in colour, which was piloted by a person wearing a red suit who appeared to be in a lying down position holding onto a handlebar in front of them. The pilot of [the DA42] said they were checking the approach chart at the time and looked up to see the hang-glider, which took them by surprise, and they turned off the auto pilot, banked right and pulled back to initiate a right turn to avoid a collision. They stated that they thought, without the avoiding action, they would have likely hit the opposite direction traffic. The pilot stated their intention to also file an Airprox report for this incident.
