AIRPROX REPORT No 2025142

Date: 05 Jul 2025 Time: 1636Z Position: 5203N 00056W Location: 3.5NM ESE Silverstone

PART A: SUMMARY OF INFORMATION REPORTED TO UKAB

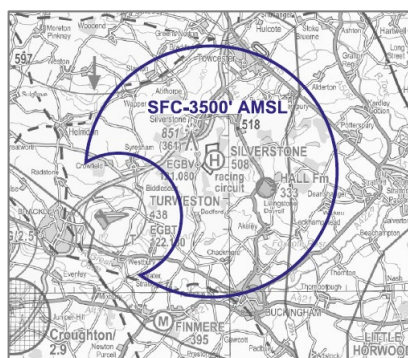
Figure 1 – Silverstone RA(T)

5. Subject to paragraph 6, between 0700 and 2000 hours on each of the three days between 04 July and ending 06 July 2025, no aircraft is to fly below 3500 FT AMSL within the area [shown in Figure 1 below].

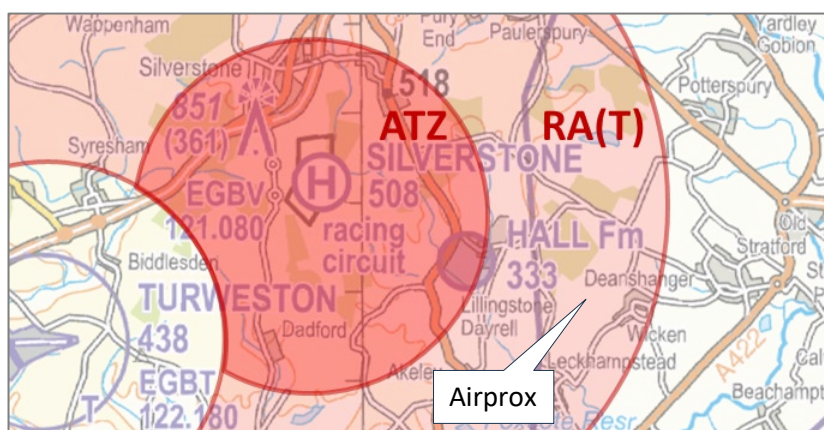
Figure 6 – The location of the ATZ and RA(T)

Members next considered the actions of the Silverstone controller, and it was noted that the RT loading of the Tower frequency had been particularly high. Members appreciated that the Airprox had occurred outside the Silverstone ATZ and the pilots involved had been in receipt of a Basic Service. An Advisor
