**AIRPROX REPORT No 2025145**

Date: 16 Jul 2025 Time: 1301Z Position: 5249N 00142W Location: Tatenhill ATZ

**PART A: SUMMARY OF INFORMATION REPORTED TO UKAB**

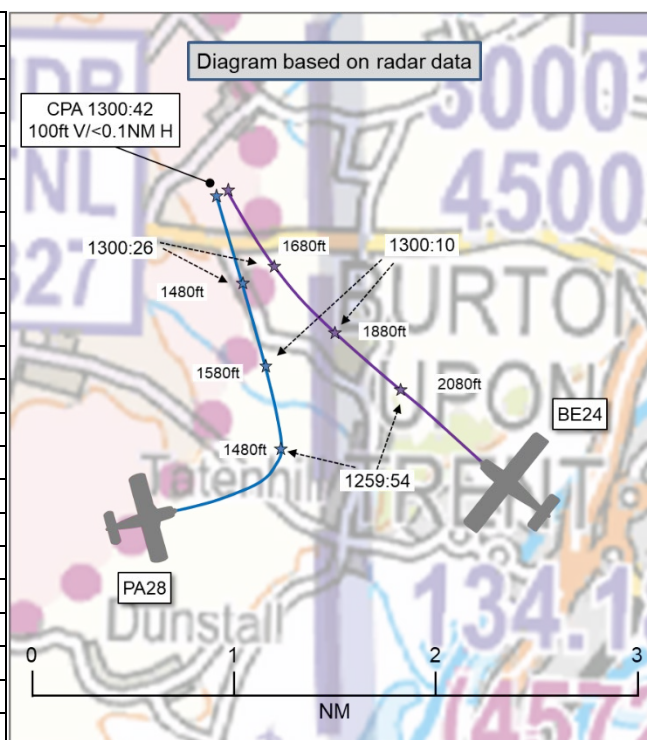
Recorded	Aircraft 1	Aircraft 2
Aircraft	PA28	BE24
Operator	Civ FW	Civ FW
Airspace	Tatenhill ATZ	Tatenhill ATZ
Class	G	G
Rules	VFR	VFR
Service	AGCS	AGCS
Provider	Tatenhill Radio	Tatenhill Radio
Altitude/FL	1480ft	1580ft
Transponder	A, C, S	A, C, S
<b>Reported</b>		
Colours	White	White
Lighting	Strobes, anti-colls	Strobes, bcn, ldg
Conditions	VMC	VMC
Visibility	>10km	>10km
Altitude/FL	900ft	1500ft
Altimeter	QFE (1000hPa)	QNH (1014hPa)
Heading	350°	~290°
Speed	90kt	90-100kt
ACAS/TAS	Not fitted	Not fitted
<b>Separation at CPA</b>		
Reported	50ft V/100-200m H	500ft V/500-1000m H
Recorded	100ft V/<0.1NM H
