AIRPROX REPORT No 2025190

Date: 26 Aug 2025 Time: 1613Z Position: 5108N 00157W Location: S of Steeple Langford

PART A: SUMMARY OF INFORMATION REPORTED TO UKAB

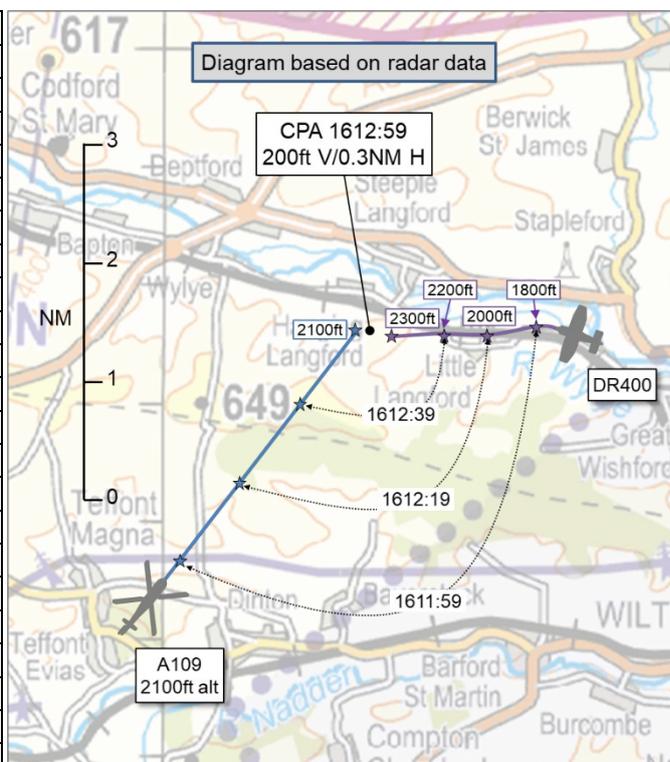
| Recorded | Aircraft 1 | Aircraft 2 |
|---|---|---|
| Recorded | 200ft V/0.3NM H | |

THE A109 PILOT reports that, while they were conducting a student solo test sortie in the vicinity of Wylie Junction at 2000ft, the crew was given a traffic advisory on UHF Boscombe Approach. The transmission was broken, with the only information readable was that the aircraft was 300ft below. It was unclear, based on the broken transmission, the direction and distance. The crew asked [the Approach controller] to say again, at which point the crew was directed to VHF on 130.005MHz. The crew switched to VHF, and a call was made back to [the Approach controller] while the copilot checked the [electronic conspicuity] ADS-B [device] and TAS display, neither of which indicated any traffic in the vicinity. [The Approach controller] repeated the traffic call quickly with a message to the effect of *"traffic 1 o'clock less than one mile 100ft below, climbing, Robin"*. The crew was quickly able to sight the traffic at the 1 o'clock, co-altitude, facing their aircraft on a constant bearing with decreasing range. The crew called to turn left and the pilot expeditiously turned left 90° and the Robin passed slightly behind the aircraft. After the turn was conducted, TAS gave a traffic alert. They estimated the closest point of approach as approximately ½ mile and less than 100ft separation. It is possible, if not likely, that if no action was taken, a collision may have occurred.
