AIRPROX REPORT No 2025176

Date: 10 Aug 2025 Time: 1005Z Position: 5049N 00016W Location: Shoreham

PART A: SUMMARY OF INFORMATION REPORTED TO UKAB

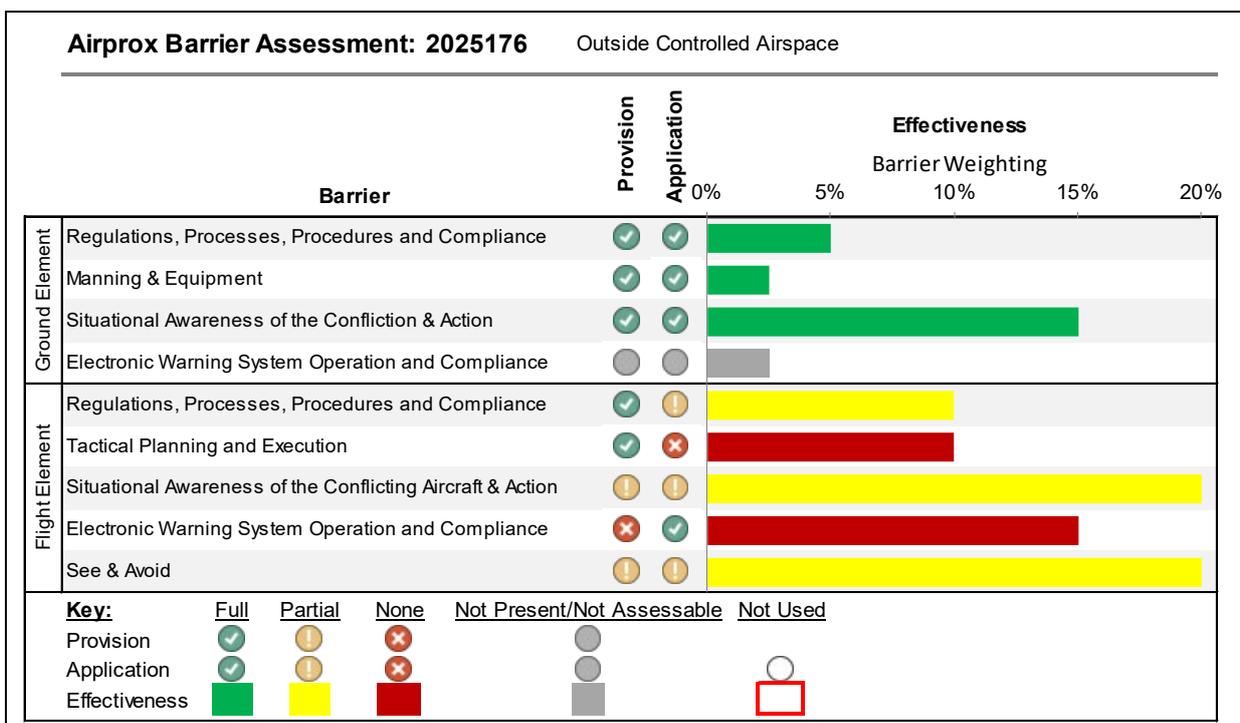
Electronic Warning System Operation and Compliance were assessed as **ineffective** because the equipment carried by the pilot of PA28(B) did not provide an alert to the presence of PA28(A) when it would have been expected to do so.

See and Avoid were assessed as **partially effective** because both pilots achieved only a late sighting of the other aircraft and, on visually acquiring PA28(A), the pilot of PA28(B) chose to turn in front of it.
