AIRPROX REPORT No 2025178

Date: 10 Aug 2025 Time: 1035Z Position: 5227N 00110E Location: E of Tibenham Airfield

PART A: SUMMARY OF INFORMATION REPORTED TO UKAB

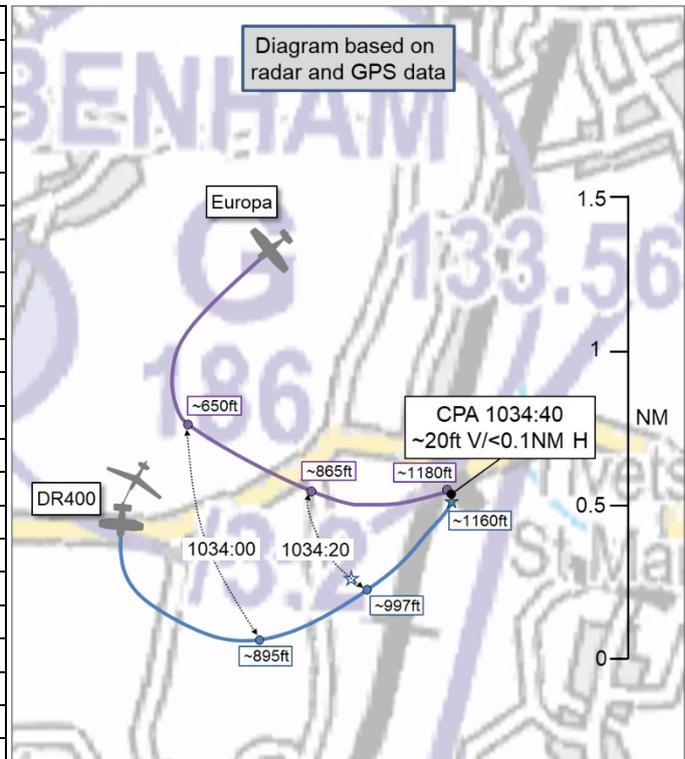
THE DR400 PILOT reports that their tug and glider combination departed RW21 at Tibenham and performed a left turn-out to climb to 2000ft AGL on a northeasterly heading. The conflicting aircraft departed after the tug and glider combination and must have turned sharply after departure to the left, effectively putting it on a potential collision course with the combination.

The pilot noted that the tug with glider under tow were climbing half a mile southeast of the airfield and the other aircraft was in their 8 o'clock position 50ft below, crossing left-to-right. No avoiding action was taken as the tug and glider combination was unable to manoeuvre before the threat had passed.

THE EUROPA PILOT reports that the tug/glider [combination] departed approximately 1-2min ahead of their take-off. After passing the winch, which was located at the upwind end of RW21, they started a climbing left turn onto an approximate heading of 120°. After passing 1200ft and estimating that they were clear of the downwind joining lane for RW21, they turned further left onto a heading of about 060°. It was at about this time that they were alerted by the glider pilot's radio call saying "(expletive) *what was that?*", and the tug pilot's calm reply saying, "*I saw it*". It was then they saw the tug/glider combination diverging from them close below and realised they must have passed very close to each other.

first sighting of the tug/glider combination was beneath them with approximately 100ft vertical and 200ft (61m) lateral separation (to their left, relative bearing 300°) while the aircraft were already diverging. They considered that 'both aircraft were climbing' as a contributory factor and that they had been focusing entirely to their right and below in anticipation of outclimbing the tug/glider combination ahead of them. On reflection, the pilot observed that they were flying solo in the Europa, with no-one in the right-hand seat, and that it might have helped had there been someone there on this occasion.
