**AIRPROX REPORT No 2025173**

Date: 05 Aug 2025 Time: 1059Z Position: 5117N 00015W Location: NW of Walton-on-the-Hill

**PART A: SUMMARY OF INFORMATION REPORTED TO UKAB**

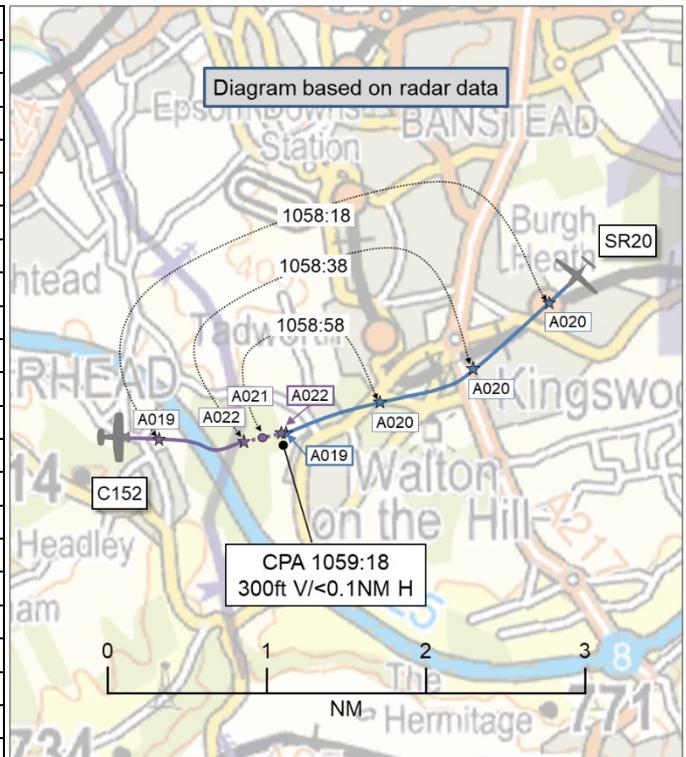
Recorded	Aircraft 1	Aircraft 2
Aircraft	SR20	C152
Operator	Civ FW	Civ FW
Airspace	London FIR	London FIR
Class	G	G
Rules	VFR	VFR
Service	None	Basic
Provider	Between frequencies	Redhill Tower
Altitude	1900ft	2200ft
Transponder	A, C, S	A, C
<b>Reported</b>		
Colours	White/blue	White/red/blue
Lighting	Strobes, nav, Indg	Beacon, Indg
Conditions	VMC	VMC
Visibility	>10km	>10km
Altitude/FL	2000ft	2300ft
Altimeter	QNH (1022hPa)	QNH
Heading	260°	090°
Speed	134kt	115kt
ACAS/TAS	TAS	Not fitted
Alert	None	N/A
<b>Separation at CPA</b>		
Reported	200ft V/0.25NM H	200ft V/0m H
Recorded	300ft V/<0.1NM H
