AIRPROX REPORT No 2025192

Date: 29 Aug 2025 Time: 1039Z Position: 5215N 00123W Location: IVO Southam

PART A: SUMMARY OF INFORMATION REPORTED TO UKAB

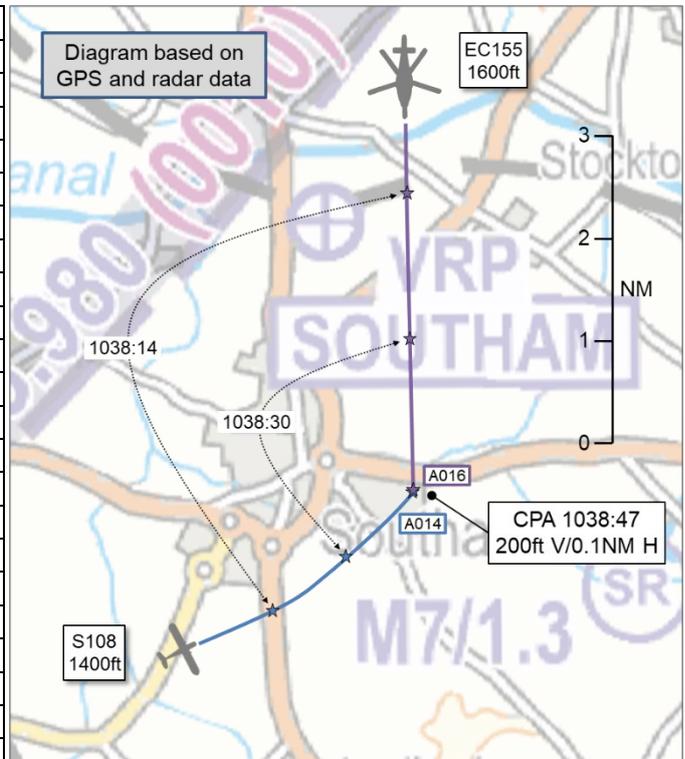
THE S108 PILOT reports that a helicopter [was first sighted as it] appeared 200ft above, in close proximity, crossing from left-to-right whilst they flew near the cloudbase. It appeared to be operating in IMC in broken cloud at a slightly higher altitude than their flight. They described their avoiding action as ‘None’.

THE EC155 PILOT reports that, while cruising at 1600ft towards Oxford, they saw traffic on TCAS converging from their right 2 o’clock. They had started to go intermittently into cloud but held their height as they thought a descent would have put them in conflict with the converging aircraft (believing it would have been underneath the cloud). They glimpsed the aircraft pass below them within an estimated 200ft.

An analysis of the NATS radar replay was undertaken and both aircraft could be positively identified from Mode S data. The S108, but not the EC155, was observed by reference to ADS-B data sources. The pilot of the EC155 kindly supplied GPS track data for their flight. The moment of CPA was assessed to have occurred between the radar sweeps at 1038:46 and 1038:50 (Figures 1 and 2). The diagram was constructed and the separation at CPA determined by combining the data sources.
