AIRPROX REPORT No 2025186

Date: 14 Aug 2025 Time: 1431Z Position: 5141N 00034W Location: Chesham

PART A: SUMMARY OF INFORMATION REPORTED TO UKAB

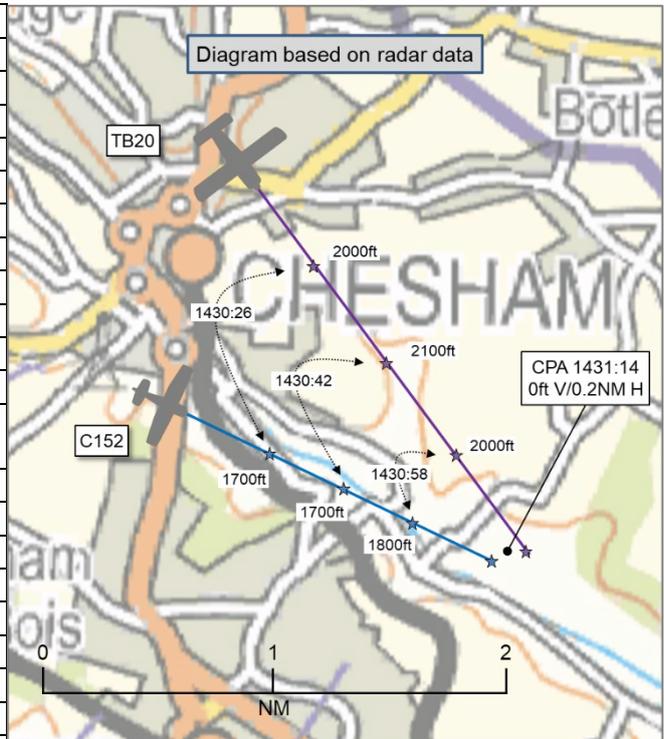
Recorded	Aircraft 1	Aircraft 2
Aircraft	C152	TB20
Operator	Civ FW	Civ FW
Airspace	London FIR	London FIR
Class	G	G
Rules	VFR	VFR
Service	Basic	Listening Out
Provider	Farnboro' North	Luton
Altitude/FL	1800ft	1800ft
Transponder	A, C, S	A, C, S
Reported		
Colours	Yellow, black	White, blue
Lighting	Beacon, nav	Nav, strobe, taxi, Idg
Conditions	VMC	VMC
Visibility	>10km	>10km
Altitude/FL	2000ft	1600ft
Altimeter	QNH	QNH (1018hPa)
Heading	110°	~150°
Speed	90kt	140kt
ACAS/TAS	Not fitted	TAS
Alert	N/A	None
Separation at CPA		
Reported	0ft V/100m H	NK
Recorded	0ft V/0.2NM H

THE C152 PILOT reports that their flight was returning to [destination aerodrome] after carrying out a lesson to the west of Aylesbury (the reporter had been the FI). On the return, they were tracking directly to [...] from Princess Risborough. They were practicing straight-and-level flight at the time, with an emphasis on maintenance of scan. At the time, the FI had been encouraging the student to work on their scan and had been carrying out a 'Lookout, Attitude, Instruments' exercise with them, so both of the pilots' lookout was enhanced. Workload was low as the lesson was complete and they were returning to [destination aerodrome]. An aircraft appeared to the left side of the screen from the blind spot above the wing passing in front of their aircraft, from left-to-right and appeared to be tracking towards [...] in a descent. The FI did not take any avoiding action as the speed at which it all happened did not afford enough time for a proper assessment of their track, altitude or any action they may have been taking. The other aircraft appeared to maintain track. It is possible the other aircraft pilot had not seen them as it may have been possible to pass behind. The other aircraft also appeared to be travelling faster than them. Whilst the event had been unintentional, it adds as a reminder for all of us that this portion of airspace along the east-west corridor can be an exceptionally busy sector of airspace.

THE TB20 PILOT reports that they had been flying back to their home airfield of [...] from [...]. They had routed through the Tring corridor between RAF Halton and the Luton CTR at between 2100ft and 2200ft. They were not talking to any ATS at that point but had tuned to Luton Radar 129.550MHz and set a listening squawk of 0013. Somewhere near Chesham they had seen another aircraft about 0.5NM south and a few hundred feet below. It was not showing on their traffic system. Initially, they had thought it was also routing to [...], but it became clear that it was headed more due east. Although it was slightly ahead initially, it was clear that [the TB20] was faster and would soon pass it. The TB20 pilot lost sight of it as it went behind and below them. A short while later the TB20 pilot judged that it had been well

In considering risk, members noted that neither pilot had any situational awareness of the presence of the other aircraft but the overtaking TB20 pilot had gained visual with the C152 and had judged there to have been no risk of collision. Members assessed that safety had been degraded; Risk Category C.
