AIRPROX REPORT No 2025196

Date: 04 Sep 2025 Time: 1228Z Position: 5114N 00133W Location: ivo of Thruxton Airfield

PART A: SUMMARY OF INFORMATION REPORTED TO UKAB

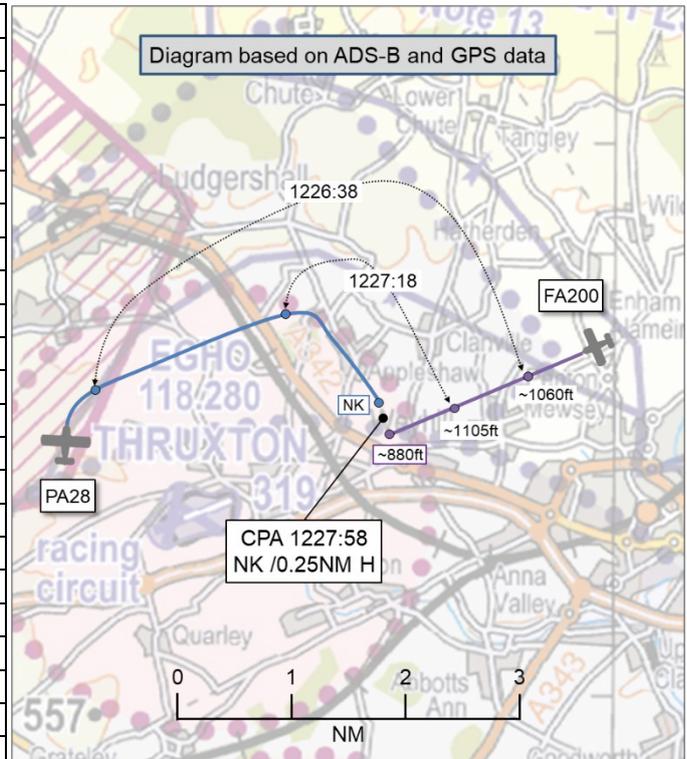
Recorded	Aircraft 1	Aircraft 2
Aircraft	PA28	FA200
Operator	Civ FW	Civ FW
Airspace	Thruxton ATZ	Thruxton ATZ
Class	G	G
Rules	VFR	VFR
Service	AGCS	AGCS
Provider	Thruxton Radio	Thruxton Radio
Altitude	NR	~880ft
Transponder	None ¹	None ²
Reported		
Colours	Red	Red/white stripes
Lighting	Bcn, nav, landing	Nav and landing
Conditions	VMC	VMC
Visibility	>10km	>10km
Altitude	550ft AGL	~600ft AGL
Altimeter	QFE (993hPa)	QFE
Heading	160°	251°
Speed	80kt	80kt
ACAS/TAS	SkyEcho	Not fitted
Alert	None	N/A
Separation at CPA		
Reported	50ft V/100m H	Not seen
Recorded	NK V/ 0.25NM H
