**AIRPROX REPORT No 2025185**

Date: 15 Aug 2025 Time: 1253Z Position: 5346N 00114W Location: Sherburn-in-Elmet ATZ

**PART A: SUMMARY OF INFORMATION REPORTED TO UKAB**

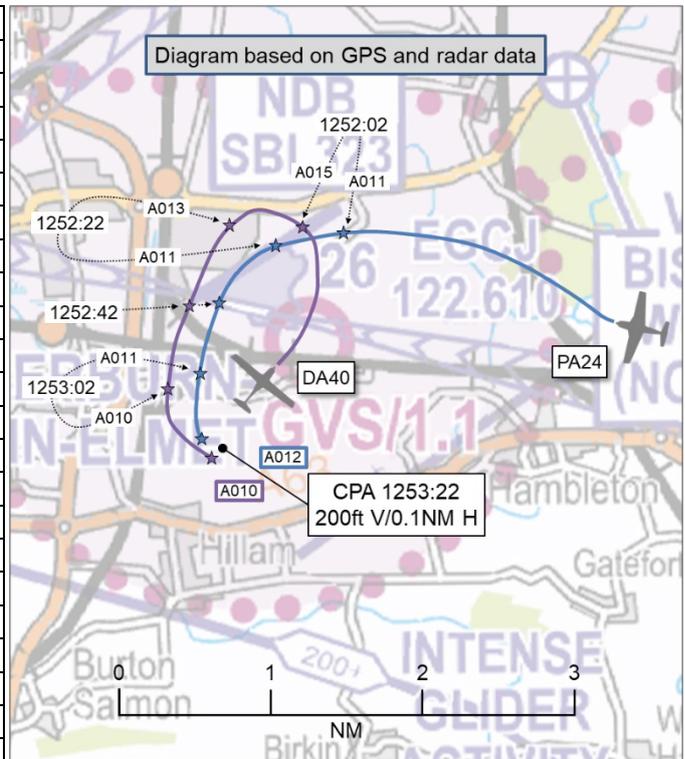
Recorded	Aircraft 1	Aircraft 2
Aircraft	PA24	DA40
Operator	Civ FW	Civ FW
Airspace	Sherburn ATZ	Sherburn ATZ
Class	G	G
Rules	VFR	VFR
Service	AGCS	AGCS
Provider	Sherburn Radio	Sherburn Radio
Altitude/FL	1200ft	1000ft
Transponder	A, C, S	A, C, S
Reported		
Colours	White, blue	White
Lighting	Bcn, anti-col, Inding	Strobes
Conditions	VMC	VMC
Visibility	>10km	>10km
Altitude/FL	1007ft	1000ft
Altimeter	QFE (1026hPa)	QFE
Heading	190°	180°
Speed	89kt	100kt
ACAS/TAS	SkyEcho	Not fitted
Alert	Information	N/A
Separation at CPA		
Reported	50ft V/50ft H	NR V/300ft H
Recorded	200ft V/0.1NM H

An analysis of the NATS radar replay was undertaken and both aircraft could be positively identified from Mode S data. The aircraft were depicted on the replay as having been at Flight Levels. A suitable correction was used to determine their altitudes. The PA24, but not the DA40, was observed by reference to ADS-B data sources. The pilot of the PA24 kindly supplied GPS track data for their flight. The diagram was constructed and the separation at CPA determined by combining the data sources.
