AIRPROX REPORT No 2025175

Date: 02 Aug 2025 Time: 1200Z Position: 5350N 00111W Location: Leeds East ATZ

PART A: SUMMARY OF INFORMATION REPORTED TO UKAB

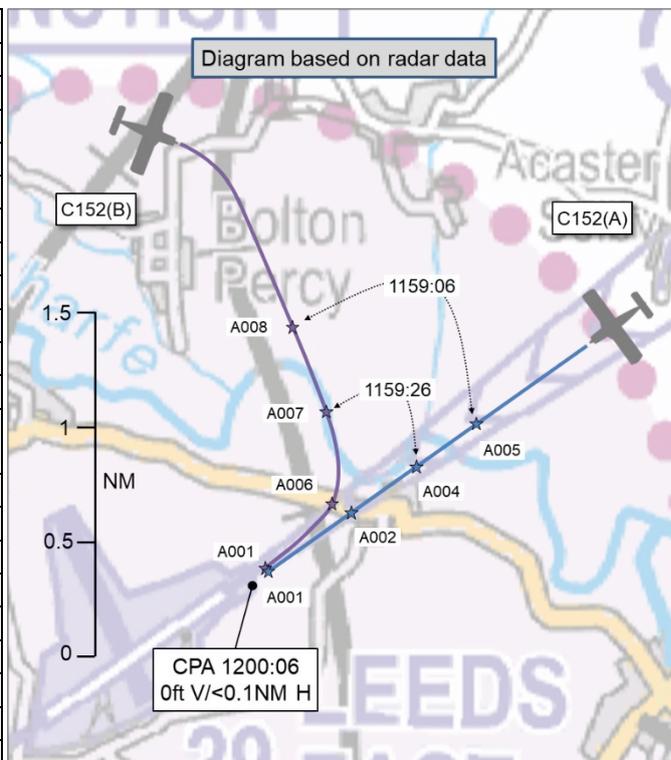
Recorded	Aircraft 1	Aircraft 2
Aircraft	C152(A)	C152(B)
Operator	Civ FW	Civ FW
Airspace	Leeds East ATZ	Leeds East ATZ
Class	G	G
Rules	VFR	VFR
Service	AGCS	AGCS
Provider	Fenton Radio	Fenton Radio
Altitude/FL	A001	A001
Transponder	A, C, S	A, C, S+
Reported		
Colours	White	White
Lighting	Strobes, nav, landing	Strobes, nav, landing
Conditions	VMC	VMC
Visibility	>10km	>10km
Altitude/FL	200ft	500ft
Altimeter	QNH	QNH (1018hPa)
Heading	240°	NK
Speed	65kt	70kt
ACAS/TAS	SkyEcho	Not fitted
Alert	None	N/A
Separation at CPA		
Reported	100ft V/100ft H	"not seen"
Recorded	0ft V/<0.1NM H

An analysis of the NATS radar replay was undertaken and both aircraft could be positively identified from Mode S data (Figure 1). The C152(B), but not C152(A), was observed by reference to ADS-B data sources.
