AIRPROX REPORT No 2025244

Date: 02 Dec 2025 Time: 1052Z Position: 5210N 00000W Location: Toft

PART A: SUMMARY OF INFORMATION REPORTED TO UKAB

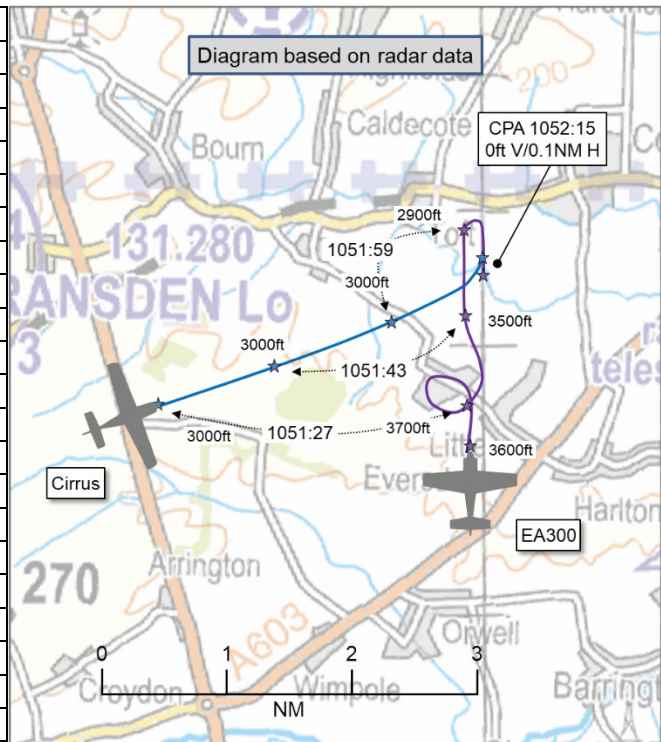
1050:37 [Cirrus c/s] was observed to the southwest of Cambridge by approximately 10NM, routing inbound at 3A, operating under a Traffic Service. Traffic was observed at the same time operating 7NM southwest of Cambridge at 3.5A, squawking 7004 (aerobatics), later identified as potentially [EA300] via Mode S. Traffic was called by the controller at this point (1050:37) and the Cirrus pilot reported the traffic in sight. The separation at this point was approximately 2.5NM.

1051:53 This marked the [point of the] last radar sweep before the radar lost the primary and secondary track of the conflicting aircraft. The controller reported that this typically occurs when an aircraft is performing very high energy manoeuvres and the radar is unable to maintain the contact. The pilot of [Cirrus c/s] reported that around the same time they observed the conflicting aircraft enter into a high energy loop manoeuvre.
