AIRPROX REPORT No 2025246

Date: 04 Dec 2025 Time: 1100Z Position: 5333N 00049E Location: 32NM E Grimsby

PART A: SUMMARY OF INFORMATION REPORTED TO UKAB

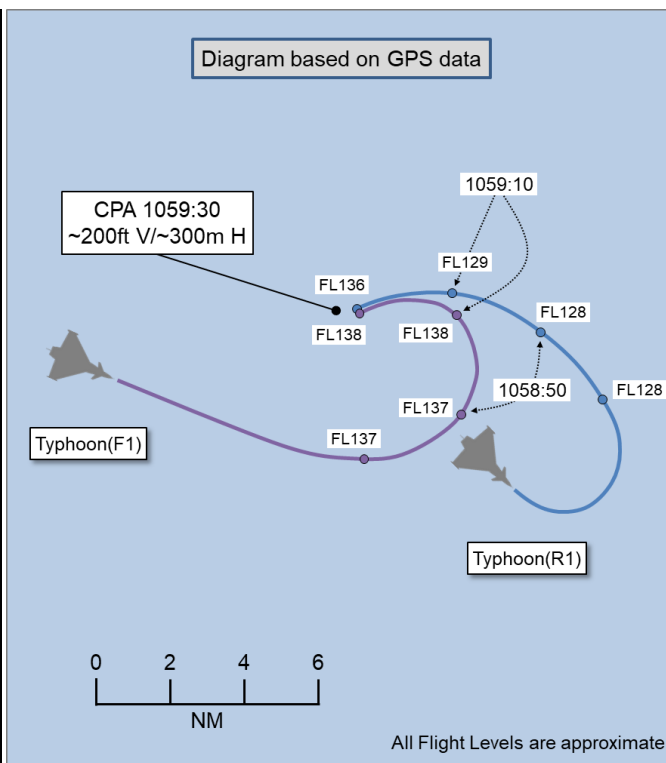
Recorded	Aircraft 1	Aircraft 2
Aircraft	Typhoon(R1)	Typhoon(F1)
Operator	HQ Air (Ops)	HQ Air (Ops)
Airspace	London FIR	London FIR
Class	G	G
Rules	VFR	VFR
Service	Listening Out	Listening Out
Provider	Voyager Boom	Voyager Boom
Altitude/FL	~FL136	~FL138
Transponder	None ¹	None ¹
Reported		
Colours		
Lighting		
Conditions		
Visibility		
Altitude/FL	NR	NR
Altimeter		
Heading		
Speed		
ACAS/TAS		
Alert		
	Separation at CPA	
Reported	300ft	NR
Recorded	~200ft V/~300m H

THE TYPHOON(R1) PILOT reports that, at 1059:30, [Typhoon(F1)] passed [Typhoon(R1)] and [Typhoon(R4)] at a perceived distance of 300ft whilst joining [the Voyager] in Air-to-Air Refuelling Area 8 (AARA8).

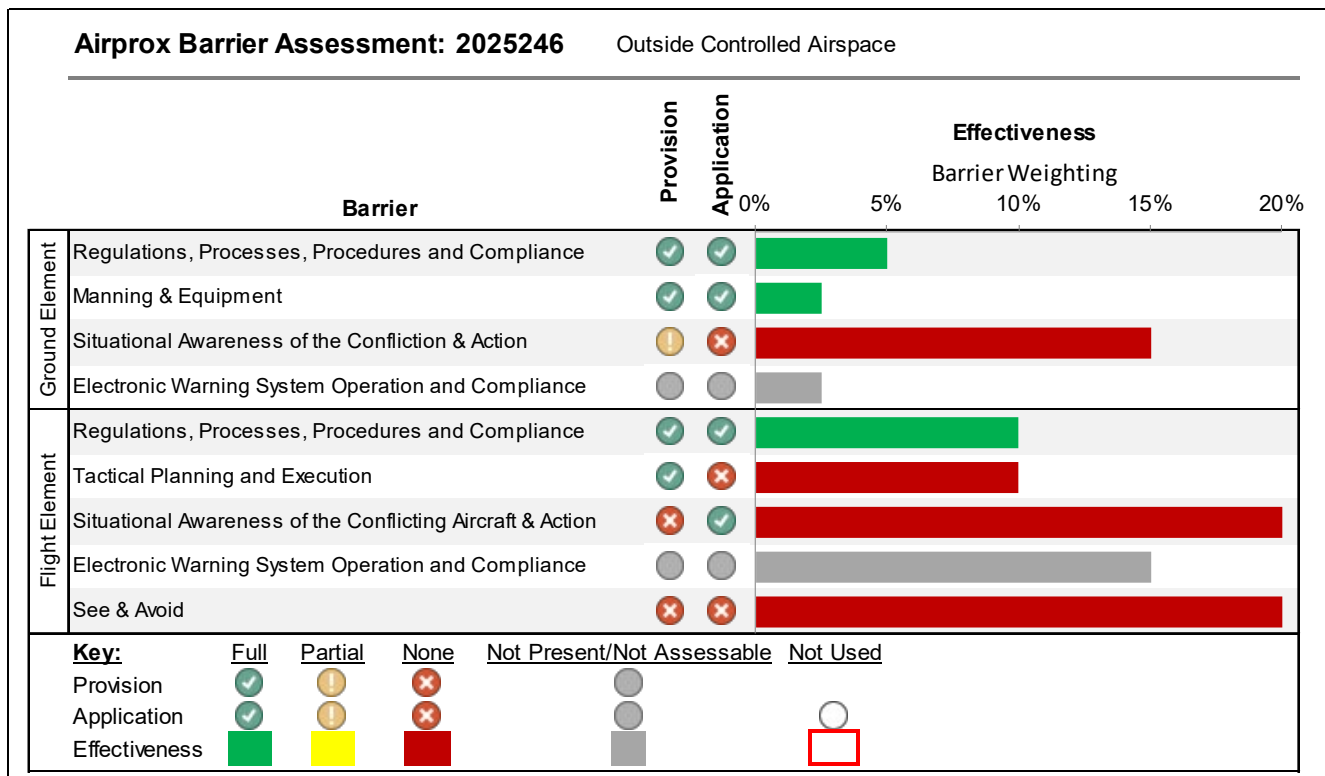
Situational Awareness of the Conflicting Aircraft and Action were assessed as **ineffective** because neither the Voyager crew, nor the pilot of Typhoon(F1), had heard (or had not assimilated) the radio call made by the pilot of Typhoon(R1) concerning their climb to FL140.

See and Avoid were assessed as **ineffective** because the pilot of Typhoon(F1), during their turn on to the heading of the tanker, had not sighted Typhoon(R1), and the pilot of Typhoon(R1) had not sighted Typhoon(F1) until the moment of CPA.
