AIRPROX REPORT No 2026002

Date: 07 Jan 2026 Time: ~1155Z Position: 5424N 00622W Location: 3NM east of Portadown

PART A: SUMMARY OF INFORMATION REPORTED TO UKAB

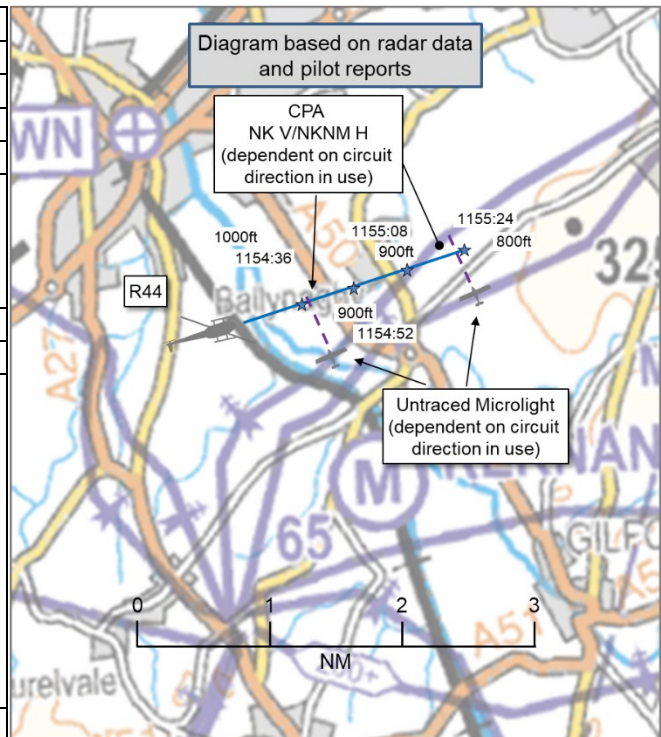
THE R44 PILOT reports that they had been en-route from [...] to [...] whilst conducting a gas pipeline survey. They observed a C42 microlight aircraft at a similar height travelling towards them from their right-hand side. They immediately took evasive action and passed below and behind the microlight at a distance of no more than 500ft. In the past, Aldergrove Radar had given traffic warnings in this area, even whilst in receipt of a Basic Service, but no such warnings were given on this occasion.
