**AIRPROX REPORT No 2026085**

Date: 21 May 2026 Time: 1321Z Position: 5121N 00106W Location: 5NM N Basingstoke

An Airprox was reported when an AW139 and a PA17 flew into proximity 5NM north of Basingstoke at 1321Z on Thursday 21<sup>st</sup> May 2026. The AW139 pilot was operating under VFR in VMC, in receipt of a Traffic Service from Southern Mil. The PA17 pilot was operating under VFR in VMC, not in receipt of a FIS.

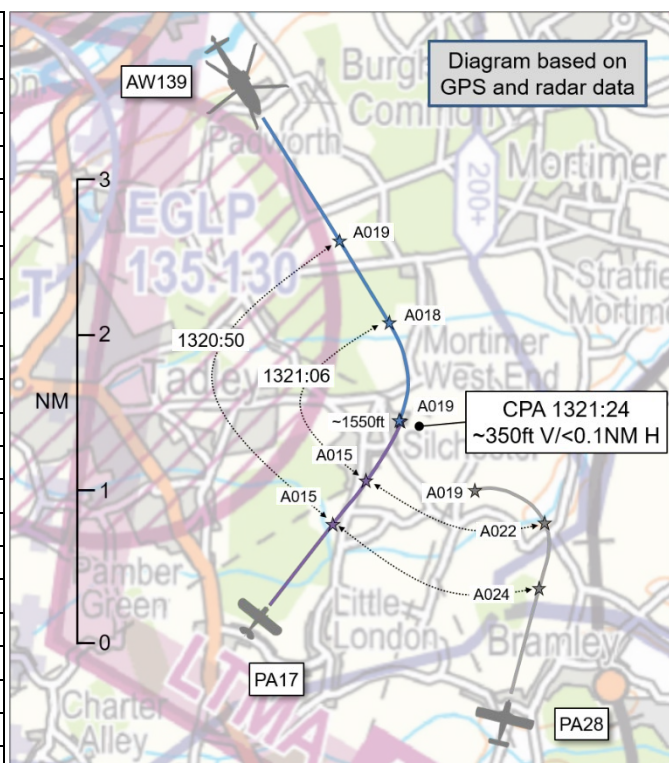
An analysis of the NATS radar replay was undertaken and the AW139, PA17 and PA28 were positively identified from Mode S data (Figure 1). All three aircraft were observed by reference to ADS-B data sources. The pilot of the AW139 kindly supplied GPS track data for their flight.
